# Compartmentation survey

Flats and Commercial Units at Lakeside  
Watermead  
Aylesbury  
Bucks  
HP19 0FX

**November 2025**

**BO/25/P24876**

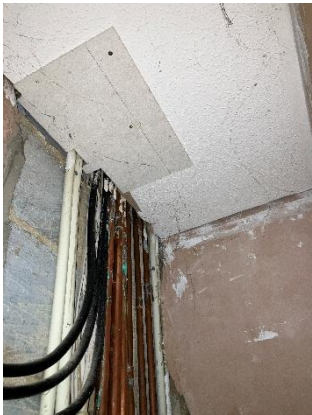
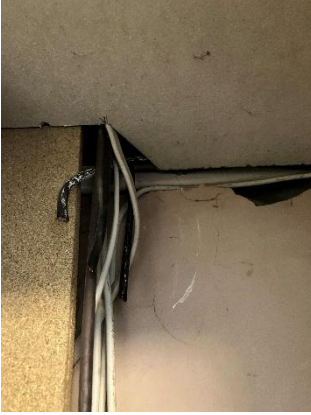
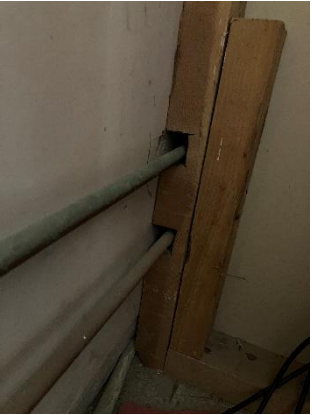
PENETRATIONS TO COMPARTMENT WALLS / CEILINGS / SERVICE CUPBOARDS	RISK
<p><b>Location:</b> Compartment walls, ceilings and service cupboard / hatch.</p> <p><b>Findings:</b> Cable and pipe penetrations are present to the service cupboards which appear to penetrate the compartment wall although our inspection was limited. Pipework and cable penetrations to floor / ceiling junction within service cupboard. Services are not firestopped with intumescent collar, fire batt or sealant.</p> <div style="display: flex; justify-content: space-around;">

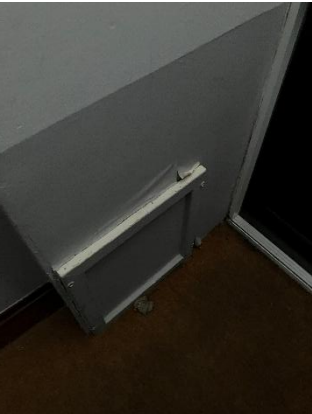
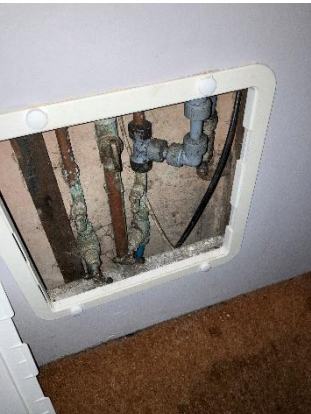
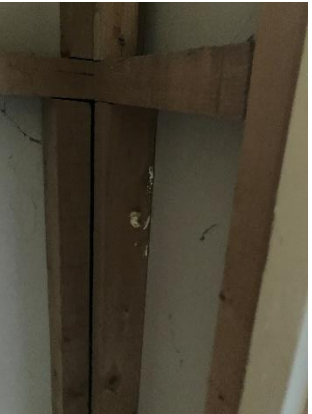
</div>	<p>High</p>
FIRE RESISTANCE OF SERVICE CUPBOARD	RISK
<p><b>Location:</b> Service cupboards</p> <p><b>Findings:</b> The walls to the service cupboard are formed in timber frame with a single, possibly plywood, lining to the outer face of the framing. The internal side of the cupboard is not fitted within an appropriate lining, and therefore the cupboard will not provide suitable fire resistance. Furthermore, several doors to the service hatches do not appear to be fire rated. The hatches and cupboards may not be designed to be fire rated, however as a precautionary advice note, it is recommended remedial work is undertaken or the design intent via the fire strategy is confirmed.</p> <div style="display: flex; justify-content: space-around;">

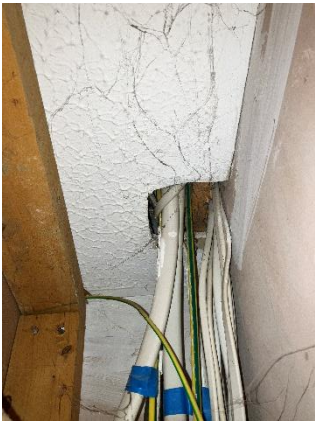
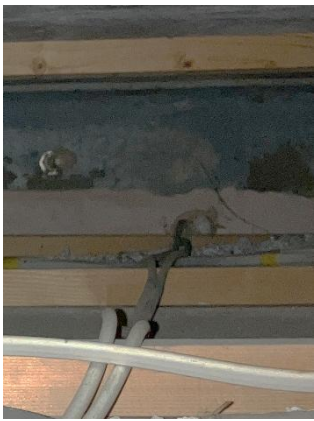
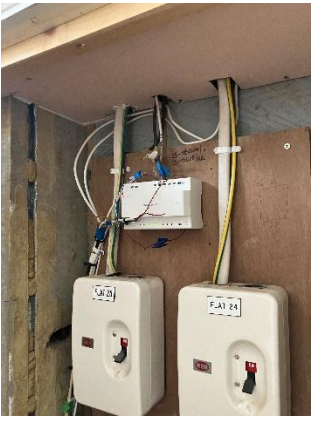
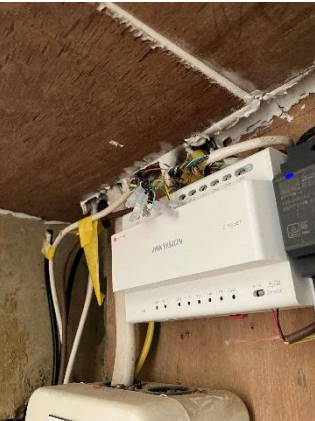
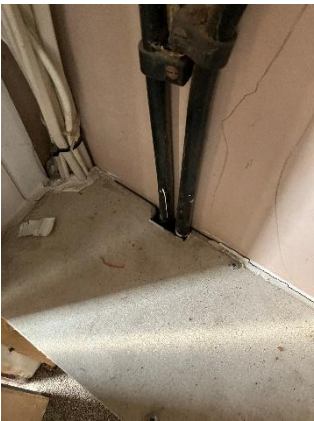
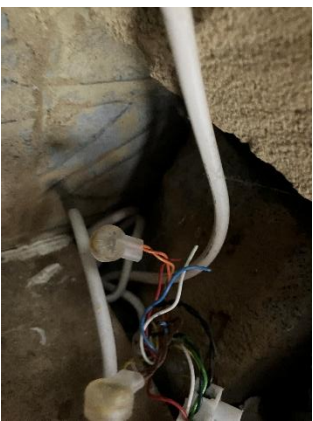
PENETRATIONS TO COMPARTMENT WALLS / CEILINGS / SERVICE CUPBOARD	RISK
<p><b>Location:</b> Compartment walls, ceiling void and service cupboard.</p> <p><b>Findings:</b> Cable and pipe penetrations are present to the compartment walls forming the service cupboard and apartments. The cable and pipe penetrations appear to extend through the walls. Where seen via the ceiling void, cables penetrated the compartment wall with no fire stopping present. Due to the penetrations, the walls and service cupboards fail to provide the required fire resistance.</p> <div data-bbox="229 707 545 1126">
