**The Linx Building**

Fire Risk Appraisal External Walls and Attachments

FE02072

Revision J

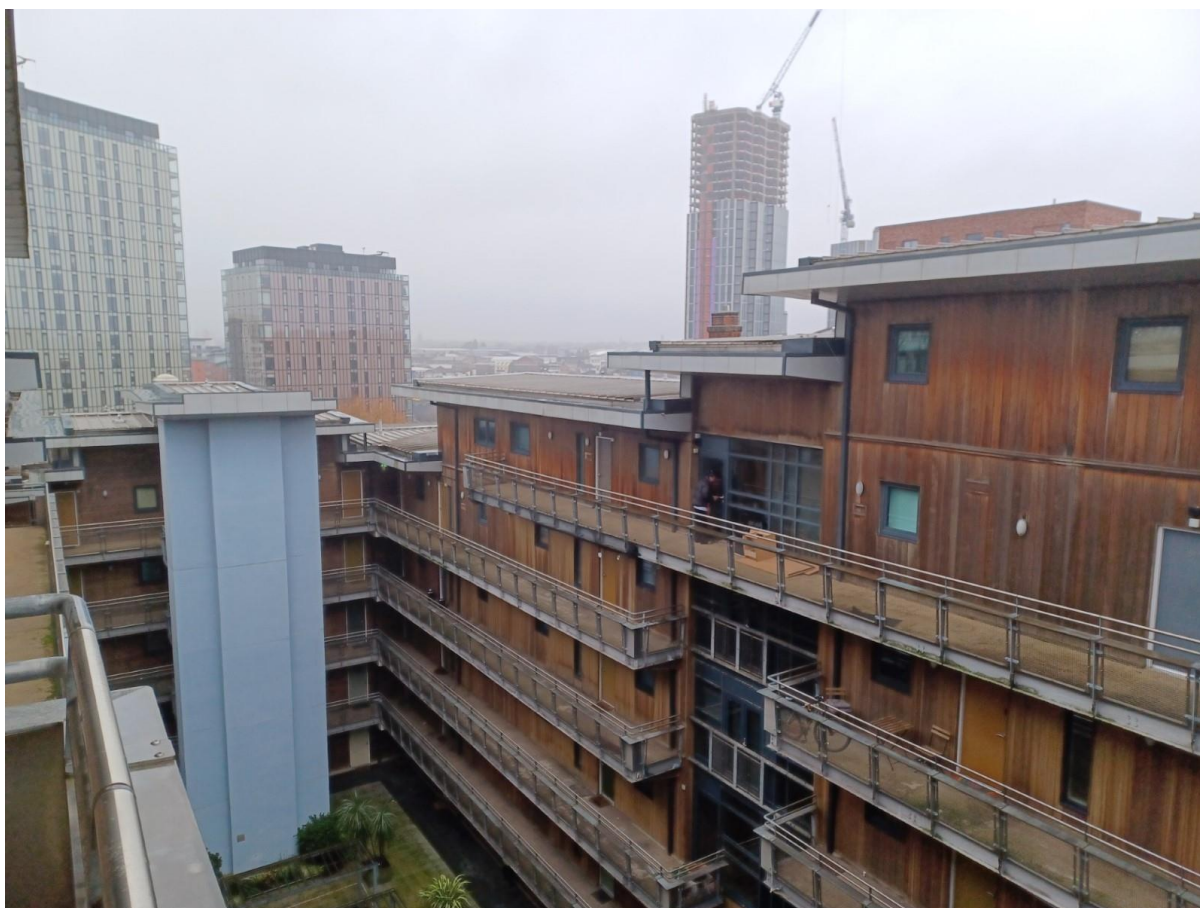
*Figure 3 Balcony approaches single means of escape*

All flats are accessed via a balcony approach, which provides a common pathway for residents. The building features two stair cores, but the balcony approaches do not connect to both stair cores. This means that residents can only access one of the stair cores, effectively limiting their means of escape to a single route in the event of an emergency. This arrangement can be observed in

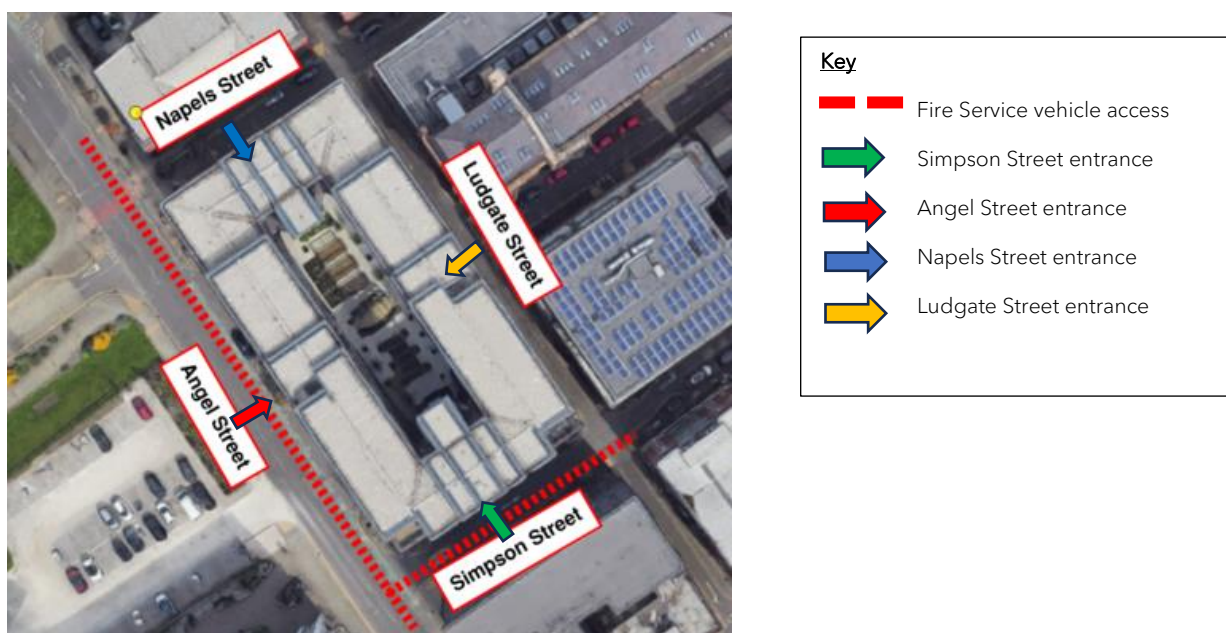
Figure 4 Fire Service Access

Ludgate Street, and Napels Street are relatively narrow, which could pose challenges for fire appliances attempting to reach the building's access points from these directions. To-scale drawings were not provided, so a detailed assessment of the accessibility for fire appliances on these streets could not be conducted. Based on satellite imagery, Simpson Street has a width of 4m, which should be able to provide access to a fire appliance in accordance with guidance at the time of construction.

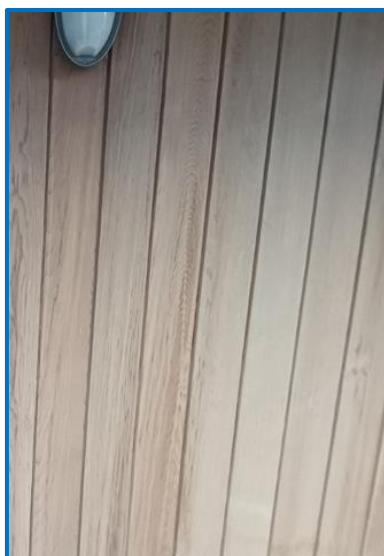
Figure 10: Wall Type 1 Vertical Cedar Wood Cladding

We have compared this external wall type to the cladding systems found on the BR135 database and we **did not** find a cladding system with the configuration and components that would constitute an exact match to what our inspections found on the building. Therefore, a BR135 benchmark rating would not be applicable in this case.

Recommended Remediation: Remove and replace all combustible materials in the wall type with materials that achieve Euroclass A2-s1, d0 or better. This also includes the sheathing board. All combustible membranes must also be removed and replaced with membranes achieving a minimum of class B-s3, d0. Install cavity barriers at the relevant locations in conjunction with the current Building Regulations in Approved Document B. This is required in all locations where this wall type is present.

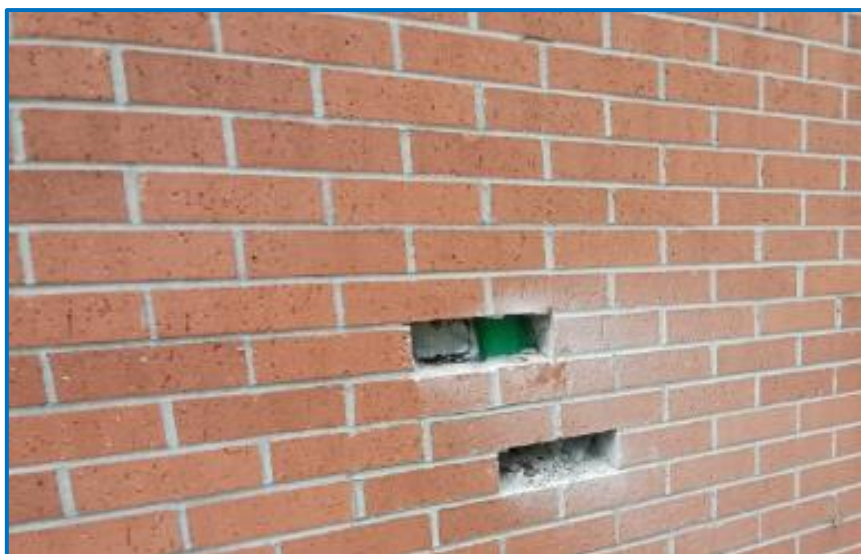
Figure 11: Wall Type 2A – Masonry with Aluminium Frame Inner Leaf

We have compared this external wall type to the cladding systems found on the BR135 database and we **did not** find a cladding system with the configuration and components that would constitute an exact match to what our inspections found on the building. Therefore, a BR135 benchmark rating would not be applicable in this case.

Recommended Remediation: Remove and replace all combustible materials in the wall type with materials that achieve Euroclass A2-s1, d0 or better. All combustible membranes must also be removed and replaced with membranes achieving a minimum of class B-s3, d0. Install cavity barriers at the relevant locations in conjunction with the current Building Regulations in Approved Document B. This is required in all locations where this wall type is present.

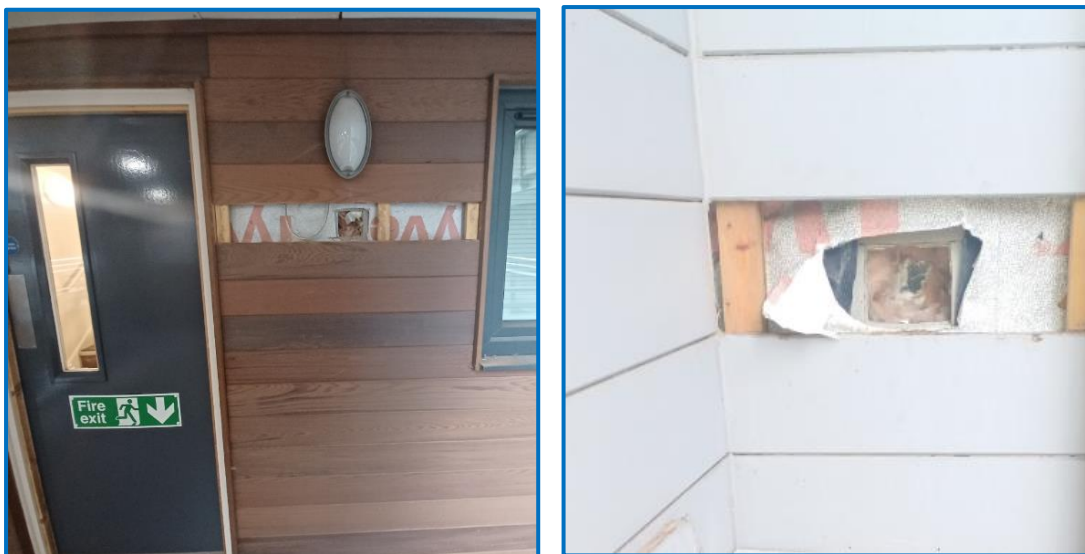
Figure 12: Wall Type 3 – Horizontal Cedar Wood Cladding

We have compared this external wall type to the cladding systems found on the BR135 database and we **did not** find a cladding system with the configuration and components that would constitute an exact match to what our inspections found on the building. Therefore, a BR135 benchmark rating would not be applicable in this case.

Recommended Remediation: Remove and replace all combustible materials in the wall type with materials that achieve Euroclass A2-s1, d0 or better. This also includes the sheathing board. All combustible membranes must also be removed and replaced with membranes achieving a minimum of class B-s3, d0. Install cavity barriers at the relevant locations in conjunction with the current Building Regulations in Approved Document B. This is required in all locations where this wall type is present.

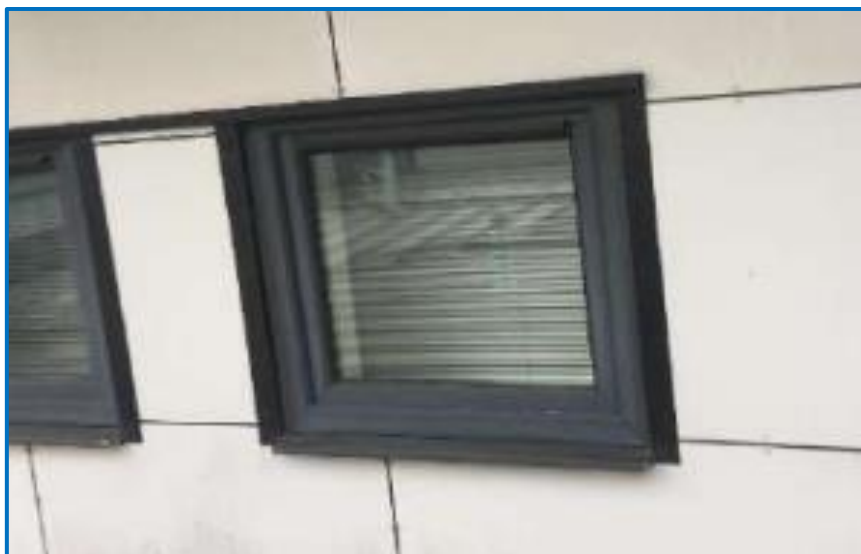
Figure 12: Wall Type 4 – Trespa Meteon

We have compared this external wall type to the cladding systems found on the BR135 database and we **did not** find a cladding system with the configuration and components that would constitute an exact match to what our inspections found on the building. Therefore, a BR135 benchmark rating would not be applicable in this case.

Recommended Remediation: Where this wall type is used as a decorative soffit, remove and replace all combustible materials in the wall type with materials that achieve Euroclass A2-s1, d0 or better. All combustible membranes must also be removed and replaced with membranes achieving a minimum of class B-s3, d0. Install cavity barriers at the relevant locations in conjunction with the current Building Regulations in Approved Document B.

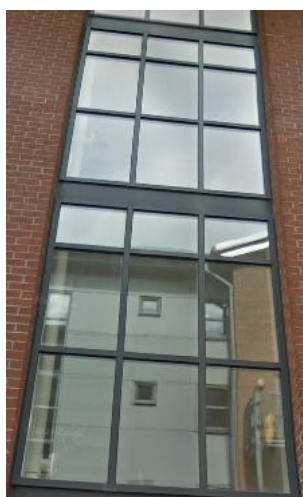
Figure 12: Wall Type 5 – Curtain Walling

We have compared this external wall type to the cladding systems found on the BR135 database and we **did not** find a cladding system with the configuration and components that would constitute an exact match to what our inspections found on the building. Therefore, a BR135 benchmark rating would not be applicable in this case.

Recommended Remediation: Remove and replace the combustible spandrel panels in the wall type with materials that achieve Euroclass A2-s1, d0 or better. Install fire stops at the relevant locations in conjunction with the current Building Regulations in Approved Document B. This is required in all locations where this wall type is present.
