Fire Door Inspection Report

Compton Property Management Ltd

The Linx Building

Conducted between 27th February -1st March 2025

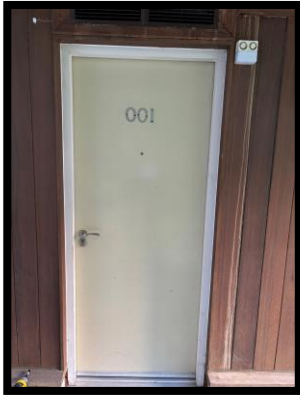
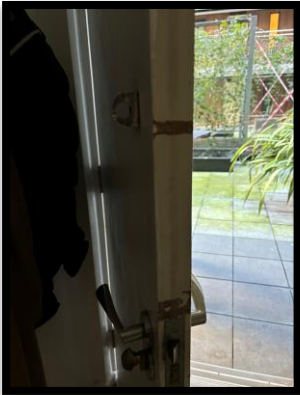
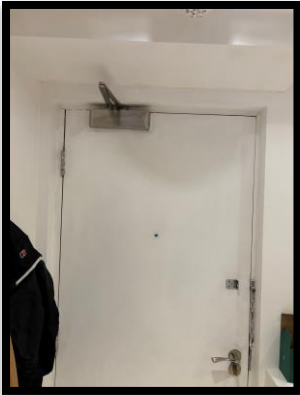
Flat 001

001	HINGES – No Faults. LOCKSET – No Faults. SEALS - No hinge or lock pads missing. CLOSER - No faults. SIGNAGE - N/A. FRAME - Ease & Adjust. DOOR - Damage to leading edge. Ease and adjust. STRUCTURE – No Faults. DOOR FAILED
002	HINGES - No Faults. LOCKSET – Loose handles. SEALS - Hinge and Lock pads missing. CLOSER - No faults. SIGNAGE - N/A. FRAME – No Faults. DOOR – Ease & Adjust 7mm gap and damage to leading edge. STRUCTURE - No Faults. DOOR FAILED
003	HINGES – Screws missing. LOCKSET – No Faults. SEALS - Hinge and lock pads missing. Intumescent strip missing. CLOSER – Cover missing. SIGNAGE - N/A. FRAME – No Faults. DOOR - Damage to leading edge. STRUCTURE – No Faults. DOOR FAILED
004	HINGES – No Faults. LOCKSET – No Faults. SEALS - Hinge and lock keep pads missing. No intumescent strip. CLOSER – No Faults. SIGNAGE - N/A. FRAME – No Faults. DOOR - Ease and adjust. STRUCTURE – No Faults. DOOR FAILED

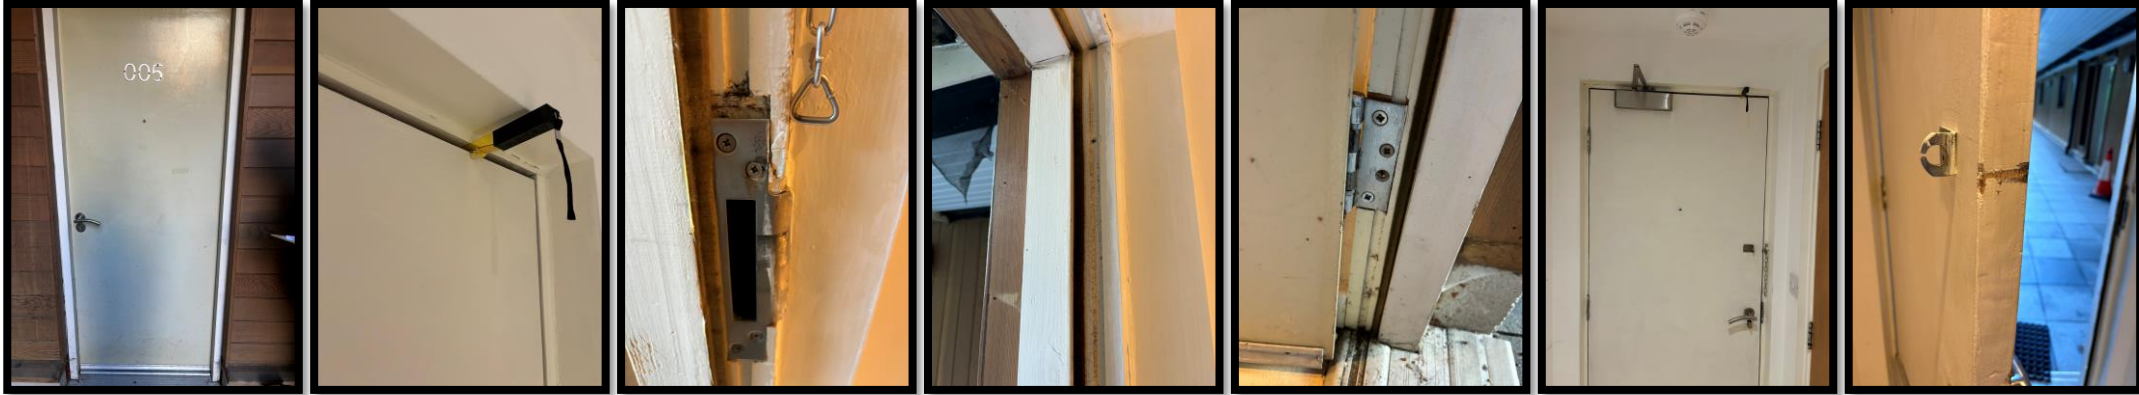
Flat 005

005	HINGES – Screws missing. LOCKSET – Poorly fitted. SEALS - Intumescent strip missing. CLOSER – No Faults. SIGNAGE - N/A. FRAME – No Faults. DOOR - Ease and adjust. Excessive damage to leading edge. Lipping needed. STRUCTURE – No Faults. DOOR FAILED
006	HINGES – Screws missing. LOCKSET – Loose handles. SEALS - Hinge and lock pads missing. Intumescent strip missing. Seal to door frame missing. CLOSER – No Faults. SIGNAGE - N/A. FRAME – Cracked frame. DOOR - Ease and adjust. Gap of 7mm. STRUCTURE – No Faults. DOOR FAILED
007	HINGES - No Faults. LOCKSET – Loose handles. SEALS – Hinge and lock pads missing. CLOSER - No faults. SIGNAGE - N/A. FRAME – No Faults. DOOR – Ease & adjust 7mm gap and damage to leading edge. STRUCTURE – No Faults. DOOR FAILED
008	HINGES - No Faults. LOCKSET – No Faults. SEALS – lock pads missing. CLOSER – No Faults. SIGNAGE - N/A. FRAME – Splits to frame. Hinges and keep overcut. DOOR – Ease & Adjust 7mm gap. Damage to leading edge can be made good. STRUCTURE - No Faults. DOOR FAILED

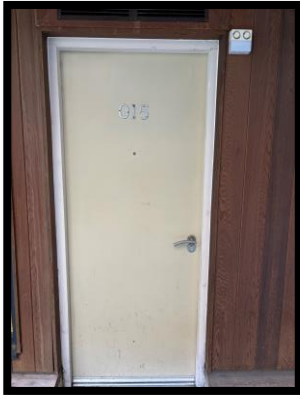
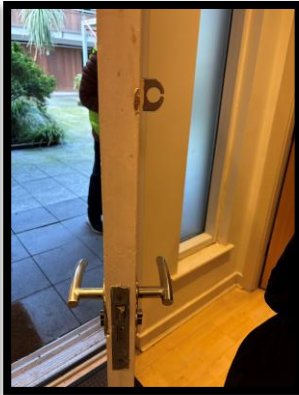
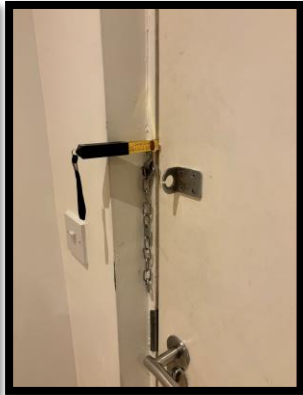
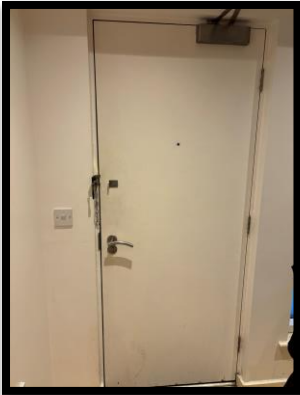
Flat 015

014	Not Available.
015	HINGES - No Faults. LOCKSET – Loose handles. SEALS – Hinge and lock pads missing. CLOSER - No Faults. SIGNAGE - N/A. FRAME – No Faults. DOOR – Ease & Adjust. Damage to leading edge with 6mm gap. STRUCTURE – No faults. DOOR FAILED
016	HINGES - No Faults. LOCKSET – No Faults. SEALS – Hinge and lock pads missing. CLOSER – No Faults. SIGNAGE - N/A. FRAME – Head of frame loose. DOOR – Ease & Adjust. STRUCTURE - No Faults. DOOR FAILED

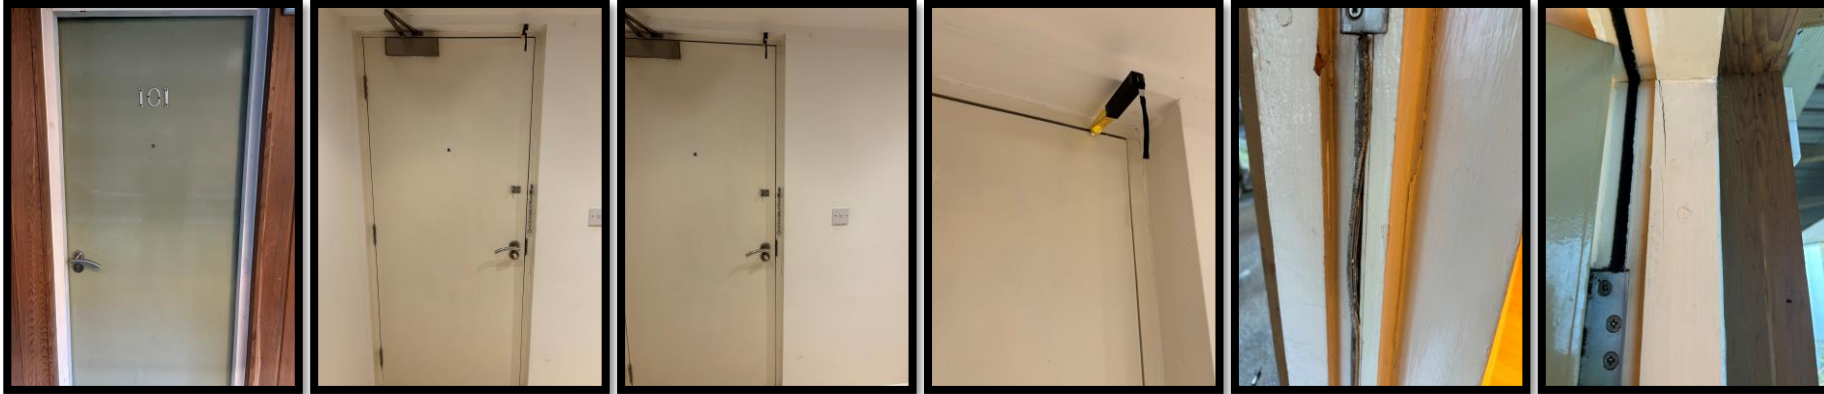
Flat 101

South Block Stair Case 1st Floor	HINGES – N/A. LOCKSET – N/A. SEALS – N/A. CLOSER – No Faults. SIGNAGE – No Faults. FRAME – Soft wood stops just pinned. DOOR – Ease and Adjust. STRUCTURE - No Faults. DOOR FAILED
Communal Door 1st Floor	HINGES – No Faults. LOCKSET – N/A. SEALS – Hinge pad missing. CLOSER – Needs to be securely fixed. SIGNAGE – No Faults. FRAME – Stops need to be replaced. DOOR – Ease and Adjust 6mm gaps. STRUCTURE - No Faults. DOOR FAILED
101	HINGES - No Faults. LOCKSET – Loose Handles. SEALS – Hinge and lock pads missing. Damaged to Intumescent strip. CLOSER – No Faults. SIGNAGE - N/A. FRAME – Cracks to frame can be repaired. DOOR – Ease & Adjust. 6.5mm to top edge. STRUCTURE - No Faults. DOOR FAILED
102	HINGES – No Faults. LOCKSET – Loose Handles. SEALS - Hinge and lock pads missing. Intumescent strip Missing. CLOSER – No Faults. SIGNAGE - N/A. FRAME – No Faults. DOOR - Ease & Adjust. Damage to leading edge with 5mm gap. Can be made good. STRUCTURE - No Faults. DOOR FAILED

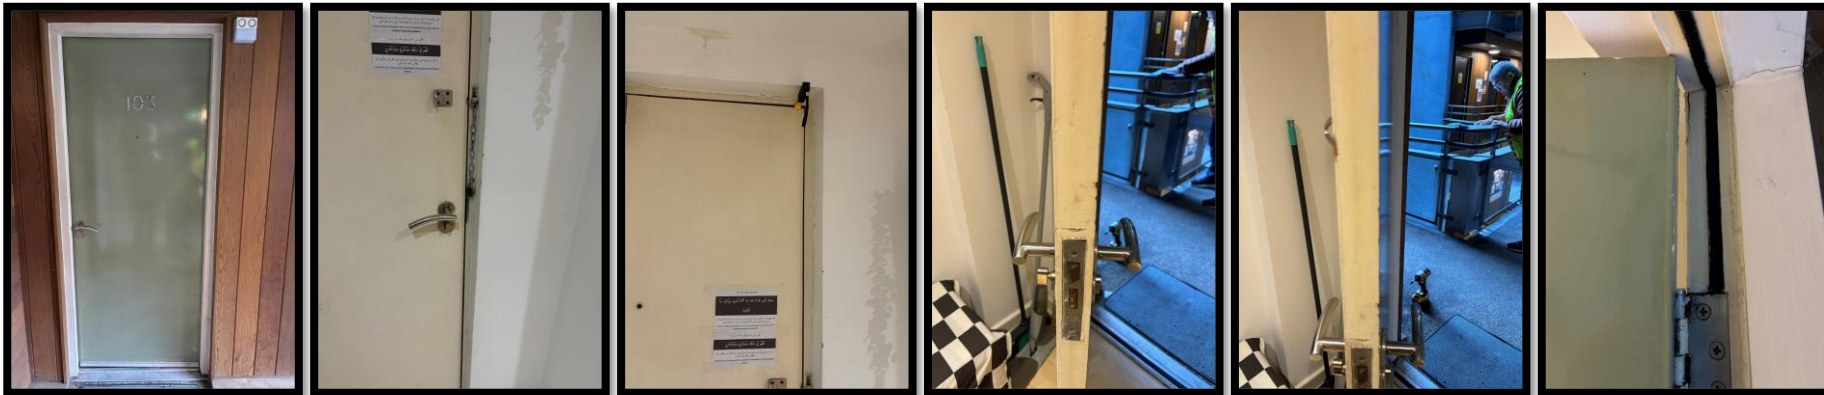
Flat 103

103	HINGES - No Faults. LOCKSET – No Faults. SEALS - Hinge and lock pads missing. CLOSER - No Faults. SIGNAGE - N/A. FRAME – Split to top edge inner frame. Can be made good. DOOR – Ease & Adjust 7mm gap. Damage to leading edge. Can be repaired. STRUCTURE - No Faults. DOOR FAILED
104	No Available.
105	HINGES - No Faults. LOCKSET – Loose Handles. SEALS - Hinge and lock pads missing. Intumescent strip cut short. CLOSER - No Faults. SIGNAGE - N/A. FRAME – Split to frame. DOOR – Ease & Adjust 7mm gap. Damage to leading edge. Gap needs lipping. STRUCTURE - No Faults. DOOR FAILED
106	Not Available.
107	HINGES – No Faults. LOCKSET – No Faults. SEALS - Lock pad missing. Intumescent strip missing on top leading edge. CLOSER – No Faults. SIGNAGE - N/A. FRAME – Gaps to top joints. DOOR – Ease & Adjust 6mm gaps on leading edge. Can be repaired. STRUCTURE - No Faults. DOOR FAILED
108	HINGES – No Faults. LOCKSET – No Faults. SEALS - Lock pad missing. CLOSER – No Faults. SIGNAGE - N/A. FRAME – Splits to frame. Hinges and keep over cut. DOOR – Ease & Adjust 7mm gap. Damage to leading edge. Can be repaired. STRUCTURE - No Faults. DOOR FAILED

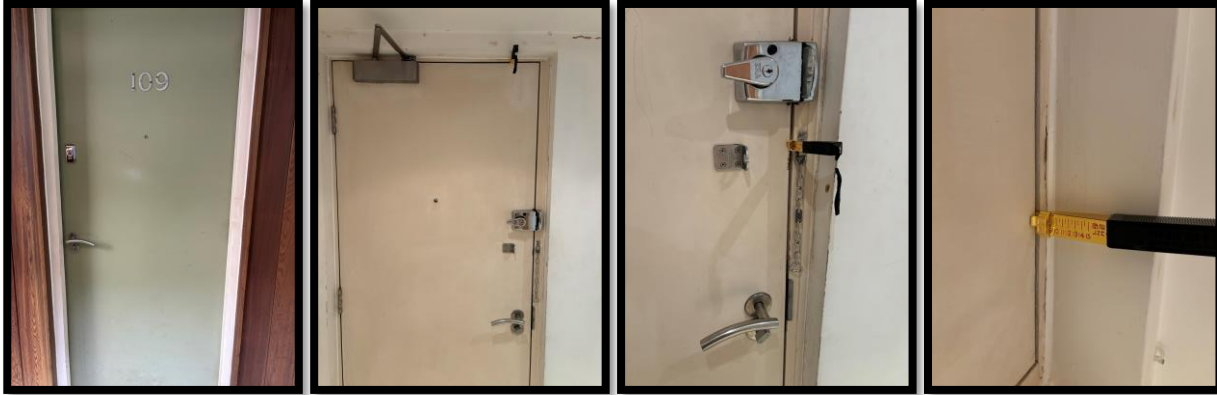
Flat 109

109	HINGES – No Faults. LOCKSET – Loose handles. SEALS – Hinge and Lock pads missing. CLOSER – No Faults. SIGNAGE - N/A. FRAME – No Faults. DOOR –Ease and Adjust 6mm gap. STRUCTURE - No Faults. DOOR FAILED
110	HINGES - No Faults. LOCKSET – No Faults. SEALS - Hinge and lock pads missing. CLOSER – No Faults. SIGNAGE - N/A. FRAME – No Faults. DOOR – Ease & Adjust 7mm gap to leading edge. Damage to leading edge. Can be repaired. Requires lipping to leading edge. STRUCTURE - No Faults. DOOR FAILED
111	HINGES - No Faults. LOCKSET – No Faults. SEALS - Hinge and lock pads missing. CLOSER – No Faults. SIGNAGE - N/A. FRAME – No Faults. DOOR – Ease & Adjust 8mm gap to leading edge. Damage to leading edge of door. Door requires lipping on leading edge. STRUCTURE - No Faults. DOOR FAILED
112	HINGES - No Faults. LOCKSET – Loose handles and no cover on mortise lock. SEALS - Hinge and lock pads missing. CLOSER – No Faults. SIGNAGE - N/A. FRAME – No Faults. DOOR – Ease & Adjust 6mm gaps. STRUCTURE - No Faults. DOOR FAILED

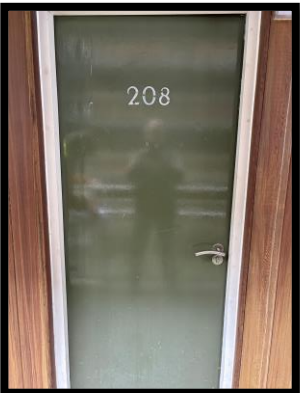
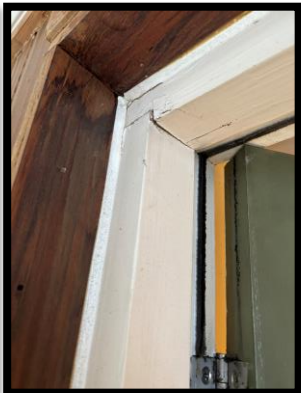
Flat 208

208	HINGES - No Faults. LOCKSET – No Faults. SEALS - Hinge and lock pads missing. CLOSER – No Faults. SIGNAGE - N/A. FRAME – Open joint to frame. DOOR – Ease & Adjust 8mm to top edge. STRUCTURE - No Faults. DOOR FAILED
209	HINGES - No Faults. LOCKSET – No Faults. SEALS – No Faults. CLOSER – No Faults. SIGNAGE - N/A. FRAME – No Faults. DOOR – No Faults. STRUCTURE - No Faults. DOOR PASSED
210	HINGES - No Faults. LOCKSET – No Faults. SEALS – Hinge and lock pads missing. Intumescent strip missing. CLOSER – No Faults. SIGNAGE - N/A. FRAME – No Faults. DOOR – Ease & Adjust 7mm gap on leading edge. Damage to leading edge. STRUCTURE - No Faults. DOOR FAILED
211	HINGES - No Faults. LOCKSET – No Faults. SEALS – No Faults. CLOSER – No Faults. SIGNAGE - N/A. FRAME – No Faults. DOOR – Ease & Adjust 7mm gap on leading edge. STRUCTURE - No Faults. DOOR FAILED
212	HINGES - No Faults. LOCKSET – No Faults. SEALS - Hinge and lock pads missing. CLOSER – Arms Missing. SIGNAGE - N/A. FRAME – No Faults. DOOR – Ease & Adjust 7mm gap to leading edge. Damage to leading edge. STRUCTURE - No Faults. DOOR FAILED

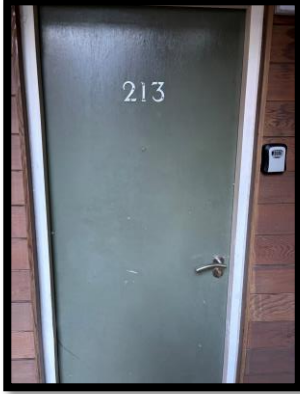
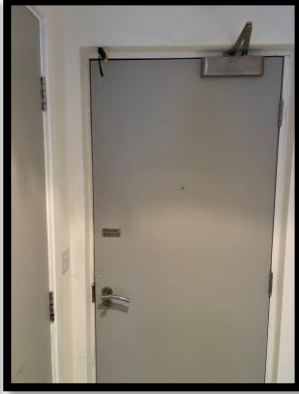
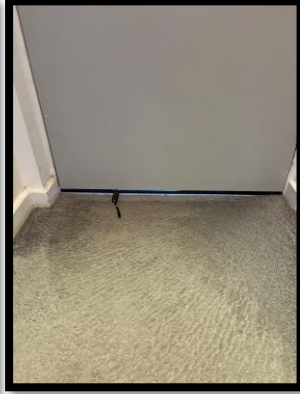
Flat 213

213	HINGES - No Faults. LOCKSET – No Faults. SEALS - Hinge and lock pads missing. CLOSER – No Faults. SIGNAGE - N/A. FRAME – No Faults. DOOR – Lipping required to top and bottom of leading edges. STRUCTURE - No Faults. DOOR FAILED
214	HINGES - No Faults. LOCKSET – No Faults. SEALS - Hinge and lock pads missing. CLOSER – No Faults. SIGNAGE - N/A. FRAME – No Faults. DOOR – Ease and adjust. Lipping to be added to top and leading edge. 10mm gap to top. STRUCTURE - No Faults. DOOR FAILED
215	HINGES - No Faults. LOCKSET – No Faults. SEALS – Intumescent strip cut short to lock keep. CLOSER – No Faults. SIGNAGE - N/A. FRAME – Lock keep overcut. DOOR – Ease & Adjust 8mm. STRUCTURE - No Faults. DOOR FAILED
216	HINGES - No Faults. LOCKSET – Loose handles. SEALS - Hinge and lock pads missing. CLOSER – No Faults. SIGNAGE - N/A. FRAME – No Faults. DOOR – Ease & Adjust 6mm gaps. STRUCTURE - No Faults. DOOR FAILED

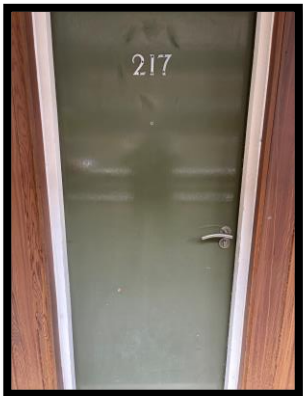
Flat 217

217	HINGES - No Faults. LOCKSET – Loose handles. SEALS - Hinge and lock pads missing. CLOSER – No Faults. SIGNAGE - N/A. FRAME – No Faults. DOOR – No Faults. STRUCTURE - No Faults. DOOR FAILED
218	HINGES - No Faults. LOCKSET – No Faults. SEALS - No Faults. CLOSER – No Faults. SIGNAGE - N/A. FRAME – No Faults. DOOR – No Faults. STRUCTURE - No Faults. DOOR PASSED

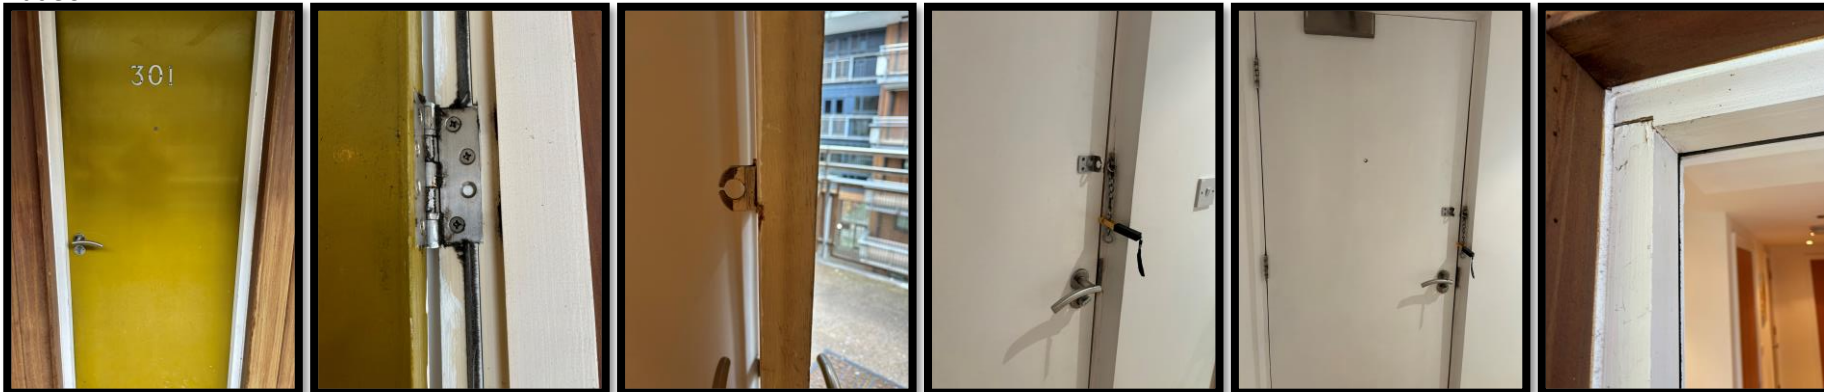
Flat 301

South Block Stair Case 3rd floor	HINGES – Pass. LOCKSET – N/A. SEALS – Hinge pad missing. CLOSER – No Faults. SIGNAGE – No Faults. FRAME – Soft wood stop needs to be replaced to head door. DOOR – New lipping required. STRUCTURE - No Faults. DOOR FAILED
Communal Door 3rd Floor	HINGES – No Faults. LOCKSET – N/A. SEALS – Hinge pad missing. Intumescent strip missing. CLOSER – No Faults. SIGNAGE – No Faults. FRAME – No Faults. DOOR – Gaps. Lipping required on leading edge. STRUCTURE - No Faults. DOOR FAILED
301	HINGES – Screw Missing. LOCKSET – Loose handles. SEALS - Hinge and lock pads missing. CLOSER – No Faults. SIGNAGE - N/A. FRAME – Open joints to head of frame. DOOR – Ease & Adjust 7mm gaps to leading edge. Damage to leading edge. STRUCTURE - No Faults. DOOR FAILED
302	HINGES - No Faults. LOCKSET – No Faults. SEALS - Hinge and lock pads missing. CLOSER – No Faults. SIGNAGE - N/A. FRAME – No Faults. DOOR – Ease & Adjust 8mm gaps. Damage to leading edge. STRUCTURE - No Faults. DOOR FAILED

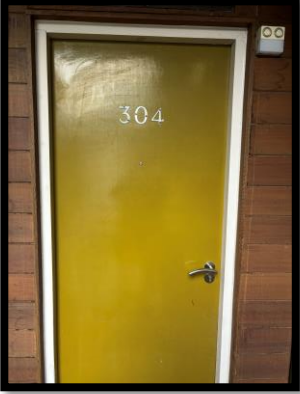
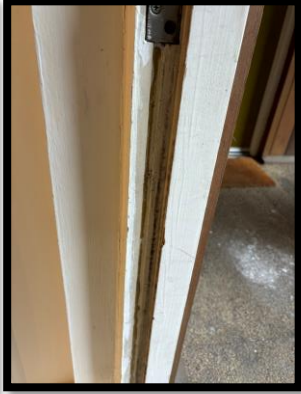
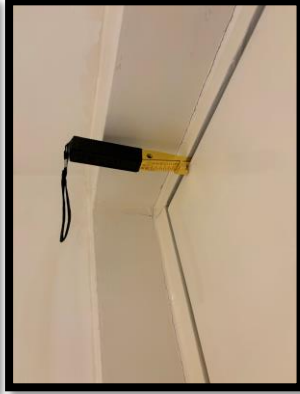
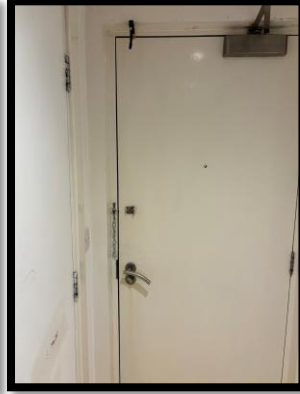
Flat 304

303	Not Available.
304	HINGES - No Faults. LOCKSET – Loose handles. SEALS - Hinge and lock pads missing. Intumescent strip missing along bottom leading edge. CLOSER – No Faults. SIGNAGE - N/A. FRAME – No Faults. DOOR – Ease & Adjust 7mm gaps at top and leading edge. STRUCTURE - No Faults. DOOR FAILED
305	Not Available.
306	HINGES - No Faults. LOCKSET – No Faults. SEALS - Lock pads missing. CLOSER – No Faults. SIGNAGE - N/A. FRAME – Keep overcut. DOOR – Ease & Adjust 6mm gap on leading edge. Damage to leading edge. STRUCTURE - No Faults. DOOR FAILED
307	HINGES - No Faults. LOCKSET – Loose handles. Needs replacing. SEALS - Hinge and lock pads missing. CLOSER – Whole Closer missing. SIGNAGE - N/A. FRAME – No Faults. DOOR – Ease & Adjust 7mm gap on leading edge. Damage to of leading edge and top of door. STRUCTURE - No Faults. DOOR FAILED
308	HINGES - No Faults. LOCKSET – No Faults. SEALS - Hinge and lock pads missing. CLOSER – Catching on the door. SIGNAGE - N/A. FRAME – No Faults. DOOR – Gaps need lipping at top and leading edge. Door veneer loose and damage to leading edge. STRUCTURE - No Faults. DOOR FAILED

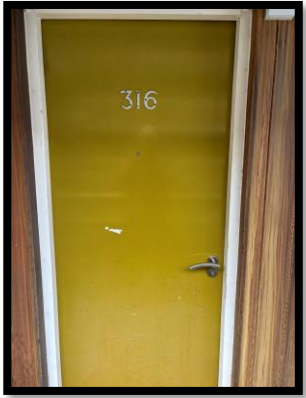
Flat 316

315	Not Available.
316	HINGES - No Faults. LOCKSET – Loose handles. SEALS - Hinge and lock pads missing. CLOSER – No Faults. SIGNAGE - N/A. FRAME – No Faults. DOOR – Ease & Adjust 5mm gap on leading Edge. STRUCTURE - No Faults. DOOR FAILED

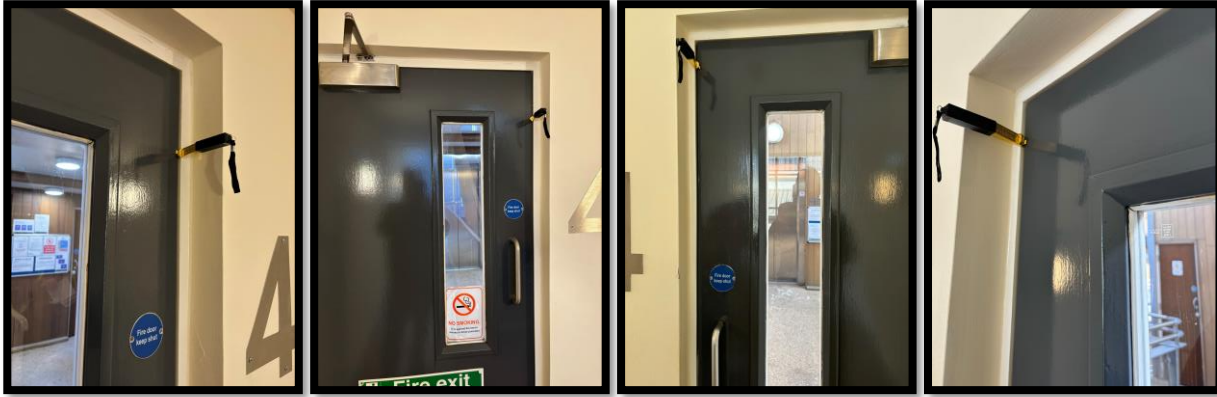
Fire Exit Doors

South Block Stair Case 4th Floor	HINGES – No Faults. LOCKSET – N/A. SEALS – Hinge pad missing. Draft excluder is over intumescent strips. CLOSER – No Faults. SIGNAGE – No Faults. FRAME – No Faults. DOOR – Door requires lipping. STRUCTURE - No Faults. DOOR FAILED
Communal Door 4th Floor	HINGES – No Faults. LOCKSET – N/A. SEALS – Hinge pad missing. Intumescent strip missing. CLOSER – No Faults. SIGNAGE – No Faults. FRAME – Soft wood stops missing. DOOR – Ease and Adjust. STRUCTURE - No Faults. DOOR FAILED
401	HINGES - No Faults. LOCKSET – No Faults. SEALS - Hinge and lock pads missing. CLOSER – No Faults. SIGNAGE - N/A. FRAME – No Faults. DOOR – Ease & Adjust 6mm gaps. Damage to leading to edge. Lipping to bottom split. STRUCTURE – Water ingress to top bulk head is affecting closure. DOOR FAILED
402	HINGES – Hinge pads incorrectly fitted on the front of hinges. LOCKSET – Pad on the outside. SEALS – Incorrect seal needs to be Combined smoke and intumescent strip. CLOSER – No Faults. SIGNAGE - N/A. FRAME – No Faults. DOOR – Ease & Adjust 5mm gap. STRUCTURE - No Faults. DOOR FAILED

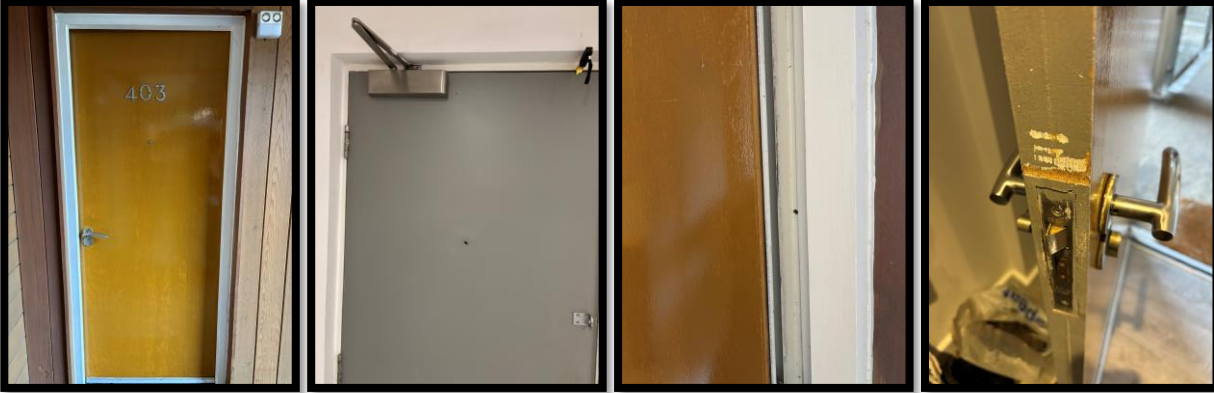
Flat 403

403	HINGES - No Faults. LOCKSET – Loose handles. SEALS – Hinge and lock pads missing. Intumescent strip missing. CLOSER – No Faults. SIGNAGE - N/A. FRAME – No Faults. DOOR – Ease & Adjust 9mm to edge. Damage to leading edge. STRUCTURE - No Faults. DOOR FAILED
404	HINGES - No Faults. LOCKSET – Loose handles. SEALS – Lock pads and Intumescent strip missing. CLOSER – No Faults. SIGNAGE - N/A. FRAME – No Faults. DOOR – Ease & Adjust 8mm gap to leading edge and top of door. Lipping required to both. STRUCTURE - No Faults. DOOR FAILED
405	HINGES - No Faults. LOCKSET – Loose handles. SEALS – Hinge and lock pads missing. CLOSER – Cover missing. SIGNAGE - N/A. FRAME – No Faults. DOOR – Ease & Adjust 6mm on leading edge. Damage to leading edge. STRUCTURE - No Faults. DOOR FAILED
406	Not Available.
407	HINGES - No Faults. LOCKSET – No Faults. SEALS – Hinge and lock pads missing. CLOSER – No Faults. SIGNAGE - N/A. FRAME – Water damage at open joint. DOOR – Ease & Adjust 6mm to both the top and leading edge. Lipping required. Excessive Gap at the bottom of the door. Intumescent drop down seal or threshold required. STRUCTURE - No Faults. DOOR FAILED

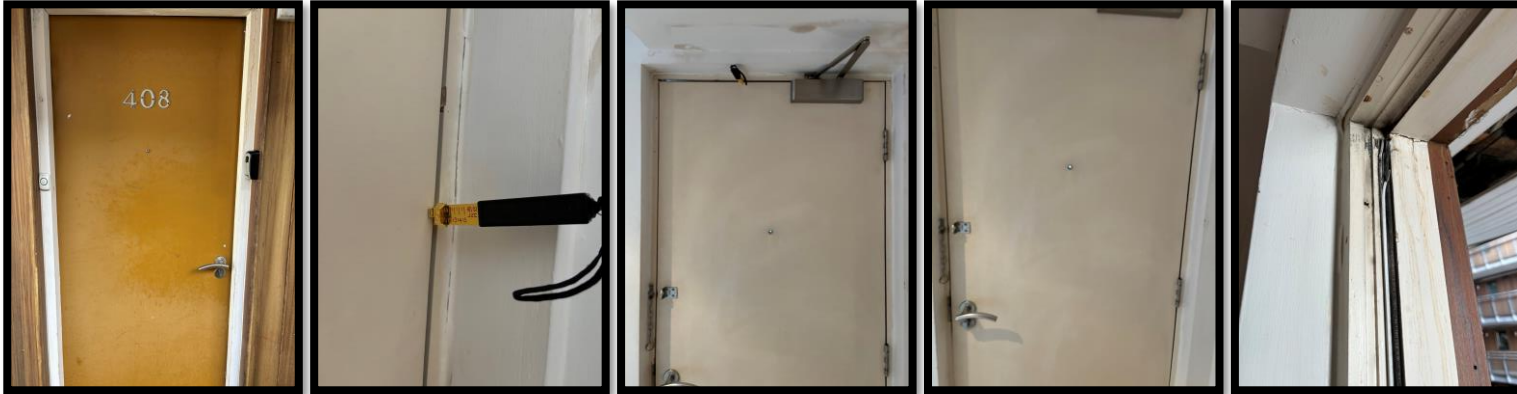
Flat 408

408	HINGES - No Faults. LOCKSET – Loose handles. Instrument strip missing. Wrong screws in keep. SEALS – Hinge and lock pads missing. Intumescent strip missing. CLOSER – No Faults. SIGNAGE - N/A. FRAME – No Faults. DOOR – Ease & Adjust 9mm -11 mm gap. Requires Lipping. STRUCTURE - No Faults. DOOR FAILED
409	HINGES - No Faults. LOCKSET – No Faults. SEALS – Hinge and lock pads missing. CLOSER – No Faults. SIGNAGE - N/A. FRAME – No Faults. DOOR – Ease & Adjust gaps to top and leading edge. Damage to leading edge of door. STRUCTURE - No Faults. DOOR FAILED
410	HINGES - No Faults. LOCKSET – No Faults. SEALS – Hinge and lock pads missing. CLOSER – No Faults. SIGNAGE - N/A. FRAME – Rotten at the bottom of frame. Open Joints to top of frame. DOOR – Door needs lipping on leading edge. STRUCTURE - No Faults. DOOR FAILED
411	HINGES - No Faults. LOCKSET – No Faults. SEALS – Hinge and lock pads missing. CLOSER – No Faults. SIGNAGE - N/A. FRAME – No Faults. DOOR – Ease & Adjust 6mm gap to top leading edge. STRUCTURE - No Faults. DOOR FAILED

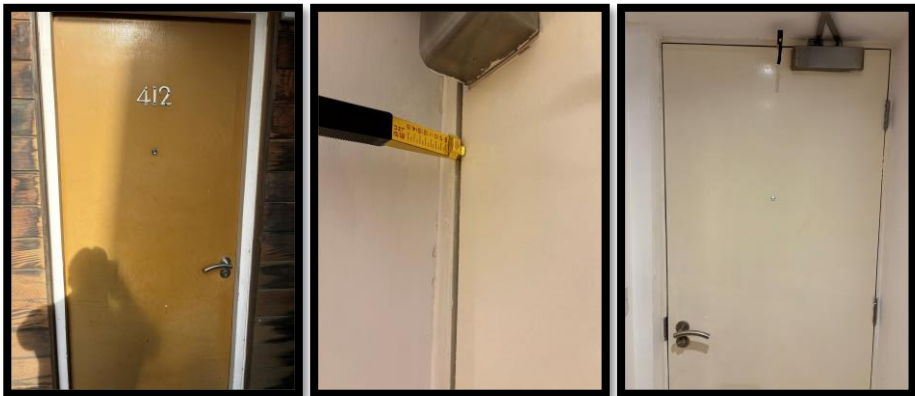
Flat 412

412	HINGES - No Faults. LOCKSET – Incorrect screws in keep. SEALS – Lock pads missing. CLOSER – No Faults. SIGNAGE - N/A. FRAME – No Faults. DOOR – Ease & Adjust. STRUCTURE - No Faults. DOOR FAILED
413	HINGES - No Faults. LOCKSET – No Faults. SEALS – Hinge and lock pads missing. CLOSER – No Faults. SIGNAGE - N/A. FRAME – No Faults. DOOR – Ease & Adjust 6mm gap. Damage to leading edge. STRUCTURE - No Faults. DOOR FAILED
414	HINGES - No Faults. LOCKSET – No Faults. SEALS – Hinge and lock pads missing. CLOSER – No Faults. SIGNAGE - N/A. FRAME – No Faults. DOOR – Ease & Adjust 6-7 mm gap. STRUCTURE - No Faults. DOOR FAILED
415	HINGES - No Faults. LOCKSET – No Faults. SEALS – Hinge and lock pads missing. CLOSER – No Faults. SIGNAGE - N/A. FRAME – No Faults. DOOR – Ease & Adjust. STRUCTURE - No Faults. DOOR FAILED
416	HINGES - No Faults. LOCKSET – No Faults. SEALS – Hinge and lock pads missing. CLOSER – No Faults. SIGNAGE - N/A. FRAME – No Faults. DOOR – Ease & Adjust on top edge. STRUCTURE - No Faults. DOOR FAILED

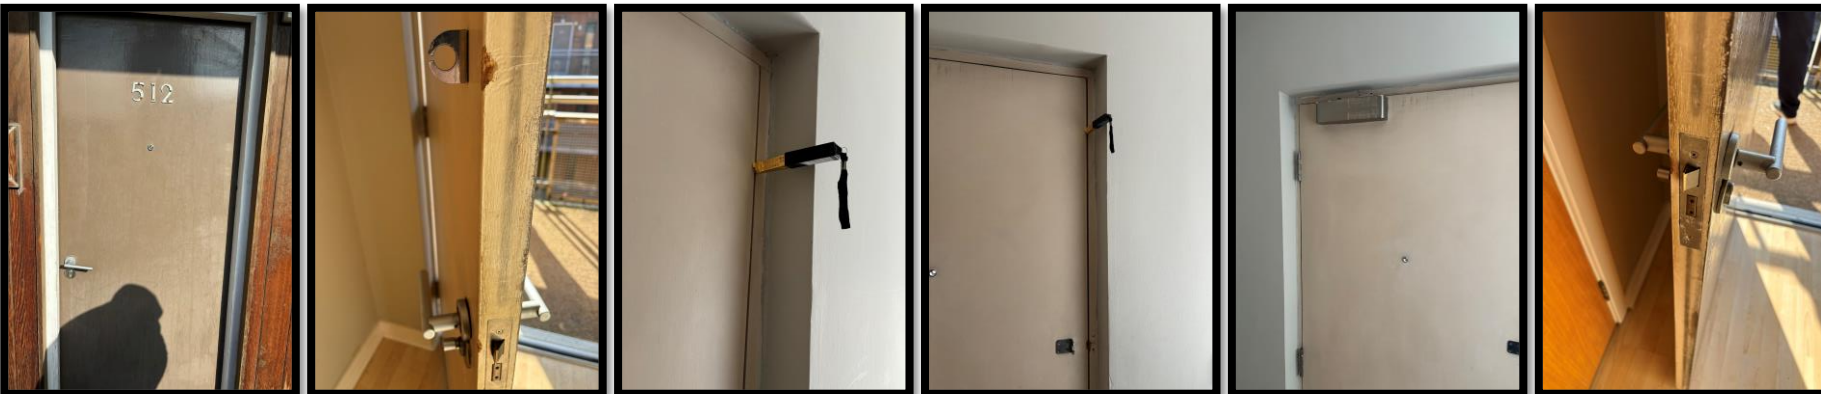
Flat 512

512	HINGES - No Faults. LOCKSET – Loose Handles. SEALS – Hinge and lock pads missing. CLOSER – Closer arm missing. SIGNAGE - N/A. FRAME – No Faults. DOOR – Ease & Adjust 6mm gap to top and leading edge. Damage to leading edge. STRUCTURE - No Faults. DOOR FAILED

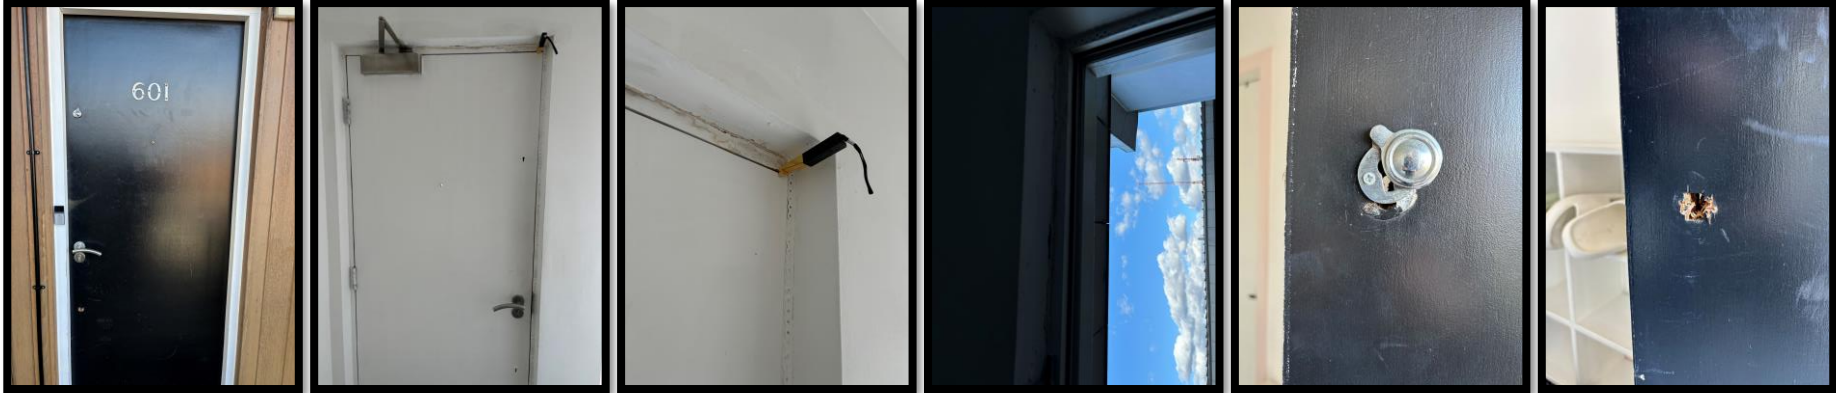
Flat 601

Communal Door 6th Floor	HINGES – No Faults. LOCKSET – N/A. SEALS – Hinge pad missing. Intumescent strip missing around hinges. CLOSER – No Faults. SIGNAGE – No Faults. FRAME – Hinges overcut. DOOR – Gaps of 6mm to top and leading edge. Door requires lipping. STRUCTURE - No Faults. DOOR FAILED
601	HINGES - No Faults. LOCKSET – Loose Handles. Escutcheon plate missing. SEALS – Hinge and lock pads missing. CLOSER – No Faults. SIGNAGE - N/A. FRAME – No Faults. DOOR – Ease and Adjust 5mm Gaps. Damage to top of door from roof leak. STRUCTURE – Water damage to inner door reveals plaster. DOOR FAILED
602	HINGES – All fixings have failed. LOCKSET - Loose handles. SEALS – Hinge and lock pads missing. CLOSER – Not working. SIGNAGE - N/A. FRAME – Rotten DOOR – DOOR FAILED Door and frame needs complete replacement.
603	HINGES – Different screws used. LOCKSET – No Faults. SEALS – Hinge and lock pads missing. CLOSER – No Faults. SIGNAGE - N/A. FRAME – No Faults. DOOR – Ease and Adjust 5.5mm Gap. STRUCTURE – No Faults. DOOR FAILED

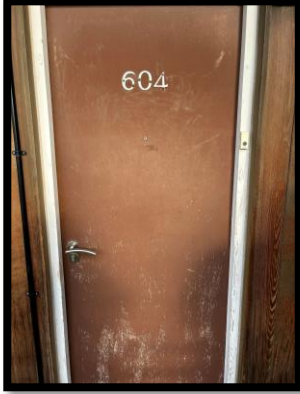
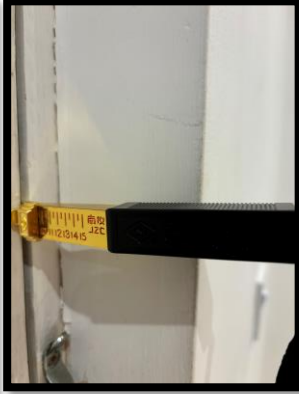
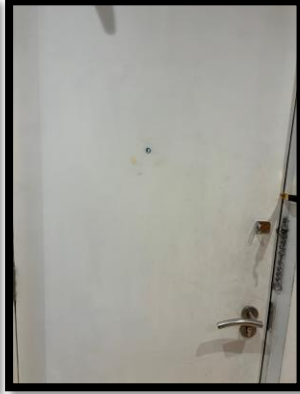
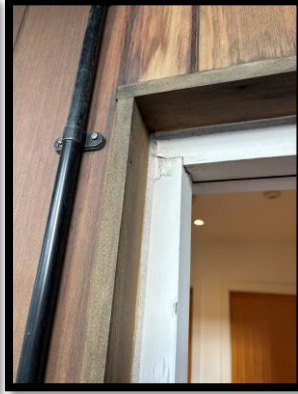
Flat 604

604	HINGES - No Faults. LOCKSET – Wrong size screws in keep. SEALS – Hinge and lock pads missing. CLOSER – No Faults. SIGNAGE - N/A. FRAME – Open Joints. DOOR – Ease and Adjust. Door needs lipping. STRUCTURE - No Faults. DOOR FAILED
