Fire Door Inspection Report
Conducted for
Compton Property Management Ltd
At
The Linx Building
10 Naples Street & 25 Simpson Street
Manchester
M4 4AS

Prepared by Gary Fenn of Gemini Building Contractors
Conducted between 9th-11th March 2023

Inspectors Notes

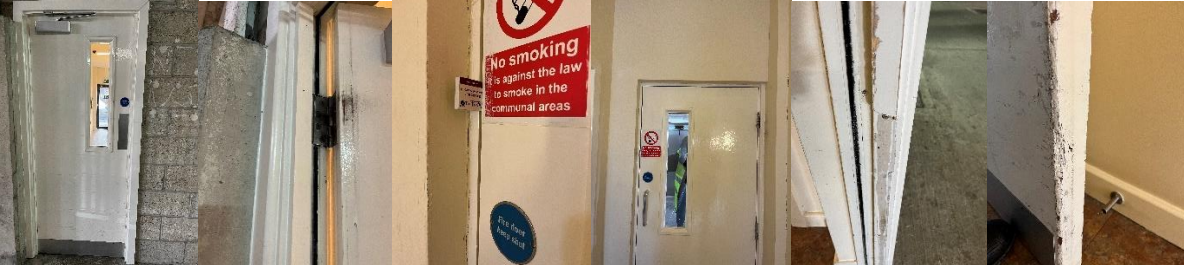
Flat 001

001	FRAME - No Faults. HINGES - No Intumescent hinge pads installed. LOCKSET - No Intumescent Pad, handle loose and screws missing. SEALS - No Faults. CLOSER - No faults. SIGNAGE - N/A. GAPS - Ease & Adjust. DOOR - Damage to Door needs to be made good. STRUCTURE – No Faults. DOOR FAILED
002	FRAME - Lock keep over cut. HINGES - No Intumescent hinge pads installed. LOCKSET - No Intumescent Pad, handle loose and screws missing. SEALS - Seals to Hinge and Lock set missing. CLOSER - No faults. SIGNAGE - N/A. GAPS - Unable to Ease & Adjust. Gap excessive. DOOR - Door split. New door size 827 x 2010 x 44. STRUCTURE - No Faults. DOOR FAILED
003	Not Available
004	Not Available
005	Not Available
006	Not Available
007	FRAME - No Faults. HINGES - No Faults. LOCKSET – Loose handle additional fixing required. SEALS – No hinge or lock keep pads. CLOSER - No faults. SIGNAGE - N/A. GAPS - Unable to Ease & Adjust. DOOR - To replace door. 823 x 2010 x 44. STRUCTURE – No Faults. DOOR FAILED

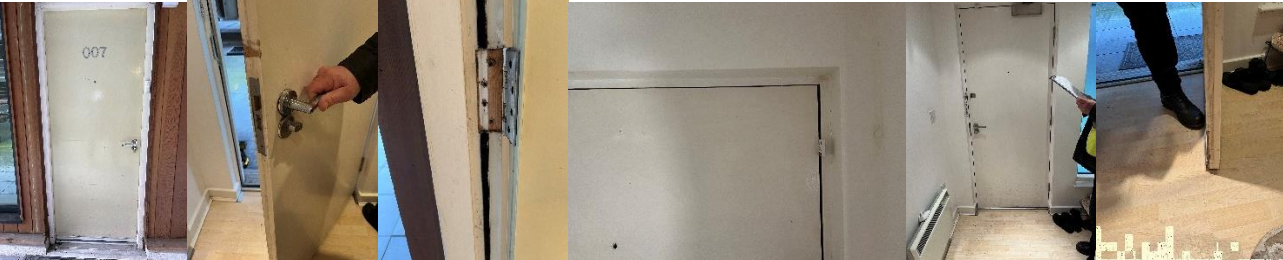
Flat 008

008	FRAME - No Faults. HINGES - No Faults. LOCKSET - Loose handle, additional screws required. SEALS - No Intumescent pads on hinge and lock keep. Intumescent perimeter strips missing and detached. CLOSER - Ease & Adjust and not latching. SIGNAGE - N/A. GAPS - Ease & Adjust. DOOR - Make good edge of door. STRUCTURE - No Faults. DOOR FAILED
009	FRAME - No Faults. HINGES - No Faults. LOCKSET - Loose handle, screws need to be tightened SEALS – No Intumescent pads on hinge and lock keep. CLOSER - Cover missing. SIGNAGE - N/A. GAPS - Ease & Adjust. DOOR – No faults. STRUCTURE - No Faults. DOOR FAILED
010	Not Available
011	FRAME - No Faults. HINGES - No Faults. LOCKSET - Loose handle, additional screws required. SEALS No Intumescent pads on hinge and lock keep. Intumescent perimeter strips missing and detached. CLOSER - Ease & Adjust not latching. SIGNAGE - N/A. GAPS - Ease & Adjust. DOOR - Make good edge of door. STRUCTURE - No Faults. DOOR FAILED

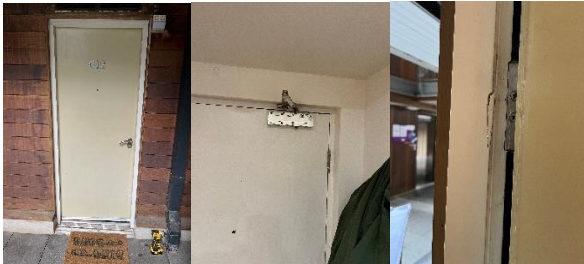
Flat 012

012	FRAME – Make good split in frame. HINGES - No Faults. LOCKSET – No faults. SEALS – No Intumescent pads and no Intumescent keep pads. CLOSER – No cover, not latching. SIGNAGE - N/A. GAPS – No faults. DOOR – No Faults. STRUCTURE - No Faults. DOOR FAILED
013	FRAME – Make good to the bottom frame. HINGES - Screw to middle hinge needs resetting. LOCKSET – Handles loose and needs refixing. SEALS – No Intumescent pads to hinges or lock keep. CLOSER – No faults. SIGNAGE - N/A. GAPS - Ease & Adjust. DOOR - Make good to edge of the door. STRUCTURE - No Faults. DOOR FAILED
014	FRAME – No faults. HINGES - No faults. LOCKSET - No faults. SEALS – No Intumescent pads to hinges and lock keep. CLOSER – Please note, closer to fierce needs adjusting. SIGNAGE - N/A. GAPS - No faults. DOOR - No faults. STRUCTURE - No Faults. DOOR FAILED
015	FRAME – No faults. HINGES - No Faults. LOCKSET – Loose handles.HanH SEALS – No Intumescent pads and no Intumescent keep pads. CLOSER - No Faults. SIGNAGE - N/A. GAPS – Ease and Adjust. DOOR – Gaps excessive. STRUCTURE – Door needs replacing. DOOR FAILED

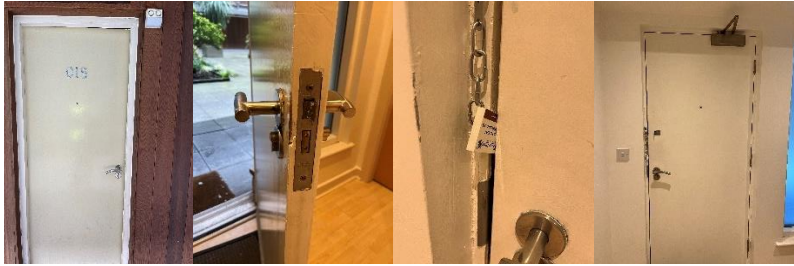
Flat 016

016	FRAME – Top right hand side frame split. Open joints. HINGES - No Faults. LOCKSET – No Faults. SEALS – Intumescent pads on hinges and keep. CLOSER – No Faults. SIGNAGE - N/A. GAPS – New door required. Gap excessive. DOOR – New door size 823 x 2060 x 44. STRUCTURE - No Faults. DOOR FAILED
Fire Door South Block Stair Case Ground Floor	FRAME - No Faults. HINGES – No Faults. LOCKSET – N/A. SEALS – No Intumescent pads on hinges and keep. CLOSER – No Faults. SIGNAGE No Faults. GAPS – Ease and Adjust. DOOR – No Faults. STRUCTURE - No Faults. DOOR FAILED
Fire Door South Block Communal Stair Case Ground Floor	FRAME - No Faults. HINGES – No Faults. LOCKSET – N/A. SEALS – No Intumescent pads on hinges and keep. CLOSER – Top arm loose. SIGNAGE No Faults. GAPS – New door 830 x 2045 x 55. DOOR – New door with Glass Pyro. STRUCTURE - No Faults. DOOR FAILED

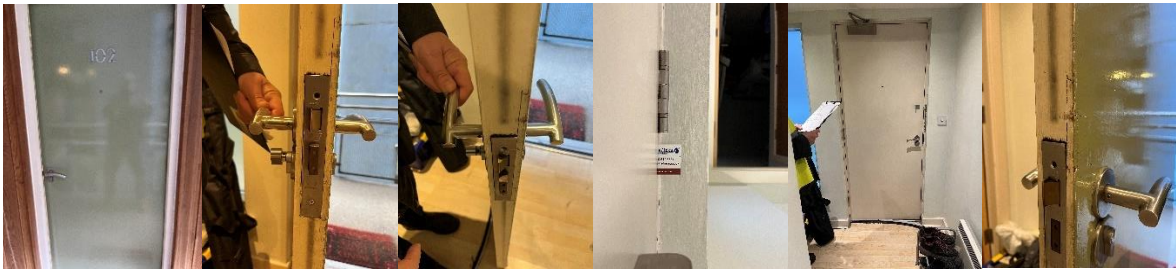
Flat 103

101	Not Available
102	FRAME - No Faults. HINGES - No Faults. LOCKSET – Screws missing on lock cover. SEALS - No Intumescent pads on hinges and keep. CLOSER – No Faults. SIGNAGE - N/A. GAPS - Ease and Adjust. DOOR - New door size 825 x 2015 x 44. STRUCTURE - No Faults. DOOR FAILED
103	FRAME - No Faults. HINGES - No Faults. LOCKSET – No Faults. SEALS - No Intumescent pads on hinges and keep. CLOSER - No Faults. SIGNAGE - N/A. GAPS - New door required. Gap excessive. DOOR - New door size 825 x 2035 x 44. STRUCTURE - No Faults. DOOR FAILED
104	FRAME - No Faults. HINGES - No Faults. LOCKSET – Handle loose. SEALS - No Intumescent pads on hinges and keep. CLOSER - Catching on threshold. SIGNAGE - N/A. GAPS - Ease and Adjust. DOOR – Make good to the door edge. STRUCTURE - No Faults. DOOR FAILED
105	Not Available
106	FRAME - No Faults. HINGES - No Faults. LOCKSET – Handle loose. SEALS - No Intumescent pads on hinges and keep. CLOSER – No Faults. SIGNAGE - N/A. GAPS - Ease and Adjust. DOOR – No Faults. STRUCTURE - No Faults. DOOR FAILED

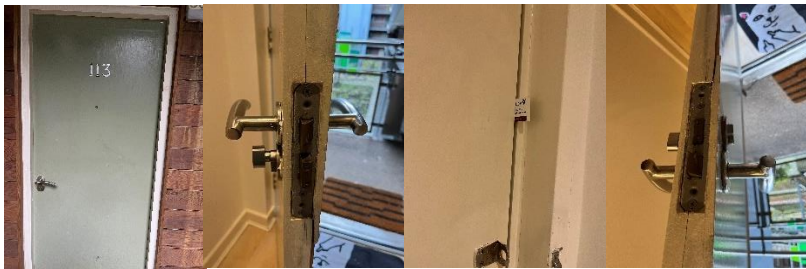
Flat 114

112	Not Available.
113	FRAME - No Faults. HINGES - No Faults. LOCKSET – Handles are loose. Keep cover missing. SEALS - No Intumescent pads on hinges and keep. CLOSER – No faults. SIGNAGE - N/A. GAPS - Ease and Adjust. DOOR – Door split. Replacement door 828 x 2040 x 44. STRUCTURE - No Faults. DOOR FAILED
114	FRAME - No Faults. HINGES - No Faults. LOCKSET – No Faults. SEALS - No Intumescent pads on hinges and keep. CLOSER – No faults. SIGNAGE - N/A. GAPS - Ease and Adjust. DOOR – Door split and needs replacing 828 2040 x 44. STRUCTURE - No Faults. DOOR FAILED
115	FRAME - No Faults. HINGES - No Faults. LOCKSET – No Faults. SEALS - No Intumescent pads on hinges and keep. CLOSER – N/A. SIGNAGE - N/A. GAPS - Ease and Adjust. DOOR – Damaged and split. New door 8030 x 2045 x 44. STRUCTURE - No Faults. DOOR FAILED
116	FRAME - No Faults. HINGES - No Faults. LOCKSET – No Faults. SEALS - No Intumescent pads on hinges and keep. CLOSER – No faults. SIGNAGE - N/A. GAPS - Ease and Adjust. DOOR – No Faults. STRUCTURE - No Faults. DOOR FAILED

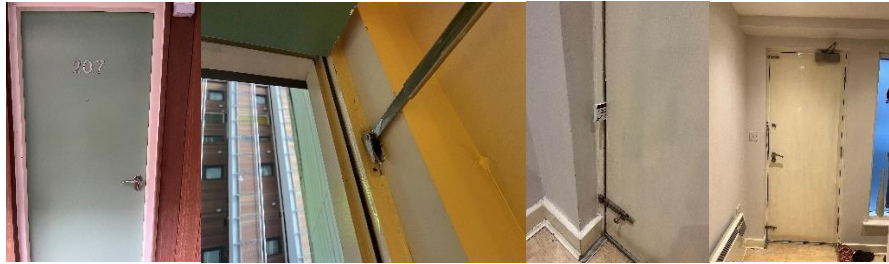
Flat 208

208	FRAME – Need to repair joint to head open. HINGES - No Faults. LOCKSET – Loose. Needs adjusting screw to keep at an angle. SEALS - No Intumescent pads on hinges and keep. CLOSER – No faults. SIGNAGE - N/A. GAPS - Ease & Adjust. DOOR – No Faults. STRUCTURE - No Faults. DOOR FAILED
209	FRAME - No Faults. HINGES - No Faults. LOCKSET – No Faults. SEALS – Unable to establish. Brush seals evident. CLOSER – No faults. SIGNAGE - N/A. GAPS – No Faults. DOOR – No Faults. STRUCTURE - No Faults. DOOR FAILED
210	FRAME - No Faults. HINGES - No Faults. LOCKSET – No Faults. SEALS – No combined Intumescent strip to frame and no Intumescent pads on hinges and keep. CLOSER – No faults. SIGNAGE - N/A. GAPS – No Faults. DOOR – No Faults. STRUCTURE - No Faults. DOOR FAILED
211	FRAME - No Faults. HINGES - No Faults. LOCKSET – No Faults. SEALS - Intumescent strip to Jam defective. No Intumescent pads on hinges and keep. CLOSER – Ease and adjust. SIGNAGE - N/A. GAPS – Ease and Adjust. DOOR – Damage to bottom edge. Can be made good. STRUCTURE - No Faults. DOOR FAILED

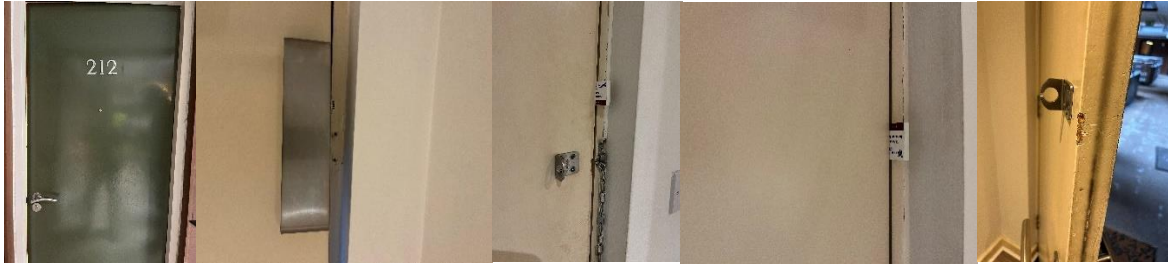
Flat 213

212	FRAME - No Faults. HINGES - No Faults. LOCKSET – No Faults. SEALS - No Intumescent pads on hinges and keep. CLOSER – No arm to closer. Needs new closer. SIGNAGE - N/A. GAPS – Ease and Adjust. DOOR – Damage to edge of the door. Can be made good. STRUCTURE - No Faults. DOOR FAILED
213	FRAME - No Faults. HINGES - No Faults. LOCKSET – No Faults. SEALS - No Intumescent pads on hinges and keep. CLOSER – Couldn't be tested. Dragging on carpet. SIGNAGE - N/A. GAPS – Gaps excessive. Needs new door. DOOR – New door. STRUCTURE - No Faults. DOOR FAILED
214	FRAME - No Faults. HINGES - No Faults. LOCKSET – No Faults. SEALS - No Intumescent pads on hinges and keep. CLOSER – No faults. SIGNAGE - N/A. GAPS – Ease and Adjust. DOOR – Door can be made good. STRUCTURE - No Faults. DOOR FAILED
215	FRAME - No Faults. HINGES - No Faults. LOCKSET – No Faults. SEALS - No Intumescent pads on hinges and keep. CLOSER – No faults. SIGNAGE - N/A. GAPS – No Faults on Ease and adjust. DOOR – No Faults. STRUCTURE - No Faults. DOOR FAILED

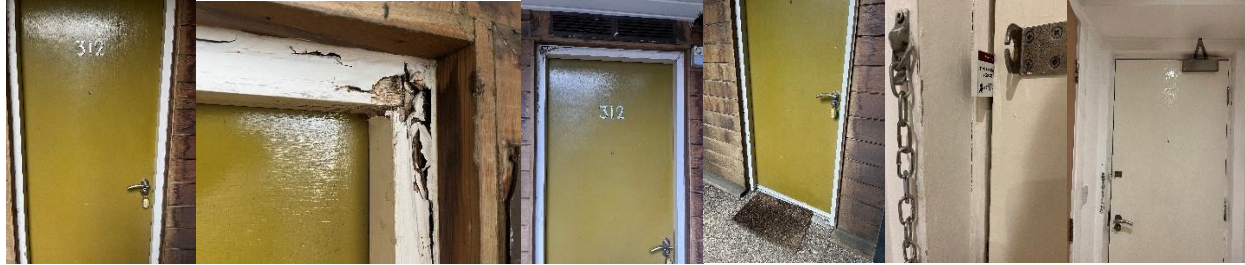
Flat 313

312	FRAME – Needs to be replaced. Frame rotten. 100W x 45D x 2090 overall. HINGES - No Faults. LOCKSET – No Faults. SEALS - No Intumescent pads on hinges and keep. CLOSER – No Faults. SIGNAGE - N/A. GAPS – Ease and Adjust. DOOR – No Faults. STRUCTURE – Due to frame condition. DOOR FAILED
313	FRAME - No Faults. HINGES - No Faults. LOCKSET – Extra Fixings and loose handle. SEALS - No Intumescent pads on hinges and keep. CLOSER – Ease and Adjust. Catching on threshold plate. SIGNAGE - N/A. GAPS – Ease and Adjust. DOOR – Damage to the edge of door. Door to be made good. STRUCTURE - No Faults. DOOR FAILED
314	FRAME – Small repair to right hand side of the frame. HINGES - No Faults. LOCKSET – Needs fixing back to the door. Screws missing. Handle loose. Face plate missing to lock. SEALS - No Intumescent pads on hinges and keep. CLOSER – Ease and Adjust. Closes to slow. SIGNAGE - N/A. GAPS – Ease and Adjust. DOOR – Some facial damage. STRUCTURE - No Faults. DOOR FAILED

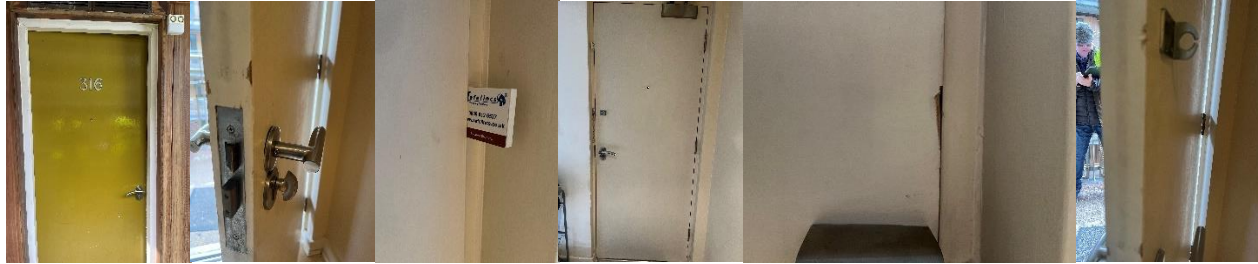
Flat 316

315	FRAME - No Faults. HINGES - No Faults. LOCKSET – No Faults. SEALS - No Intumescent pads on hinges and keep. CLOSER – No Faults. SIGNAGE - N/A. GAPS – Ease and Adjust. DOOR – Damage to leading edge. STRUCTURE - No Faults. DOOR FAILED
316	FRAME - No Faults. HINGES - No Faults. LOCKSET – Handle loose needs securing. SEALS - No Intumescent pads on hinges and keep. CLOSER – Ease and Adjust. SIGNAGE - N/A. GAPS – Ease and Adjust. DOOR – Damage to top of door and leading edge. STRUCTURE - No Faults. DOOR FAILED
Fire Door North Block 3rd floor	FRAME – Stop needed. Needs to be glued and screwed. HINGES – No Faults. LOCKSET – N/A. SEALS – No Intumescent pads on hinges and keep. Intumescent strips are damaged and need replacing. CLOSER – No Faults. SIGNAGE No Faults. GAPS – Ease and Adjust. DOOR – No Faults. STRUCTURE - No Faults. DOOR FAILED
Fire Door South Block Stair Case 3rd floor	FRAME – No Faults. HINGES – Screws not fitted correctly. LOCKSET – N/A. SEALS – No Intumescent pads on hinges and keep. No Intumescent brush strip on frame. CLOSER – No Faults. SIGNAGE No Faults. GAPS – Ease and Adjust. DOOR – Pyro glass in situ. STRUCTURE - No Faults. DOOR FAILED

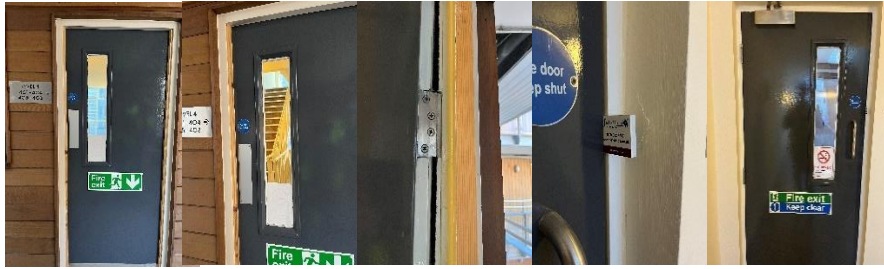
Flat 401

401	FRAME - No Faults. Minor damage to bottom of frame. HINGES - No Faults. LOCKSET – No thumb turn. SEALS - No Intumescent pads on hinges and keep. CLOSER – Ease and Adjust. SIGNAGE - N/A. GAPS – Gaps Excessive. DOOR – New door 8135 x 2130 x 44. STRUCTURE - No Faults. DOOR FAILED
402	FRAME - No Faults. HINGES – Screw missing of top hinge. LOCKSET – Screws loose in keep. Intumescent seal missing from Jam. SEALS - No Intumescent pads on hinges and keep. CLOSER – Ease and Adjust. SIGNAGE - N/A. GAPS – Ease and Adjust. DOOR – No Faults. STRUCTURE - No Faults. DOOR FAILED
403	FRAME - No Faults. HINGES - No Faults. LOCKSET – No Faults. SEALS - No Intumescent pads on hinges and keep. CLOSER – Dragging on the floor. Brush seal on the back of door. SIGNAGE - N/A. GAPS – Ease and Adjust. DOOR – No Faults. STRUCTURE - No Faults. DOOR FAILED
404	FRAME - No Faults. HINGES - No Faults. LOCKSET – No Faults. SEALS - No Intumescent pad on frame jam, hinges and keep. CLOSER – Ease and Adjust. SIGNAGE - N/A. GAPS – Gaps excessive. DOOR – New door needed 833 x 2015 x 44. STRUCTURE - No Faults. DOOR FAILED

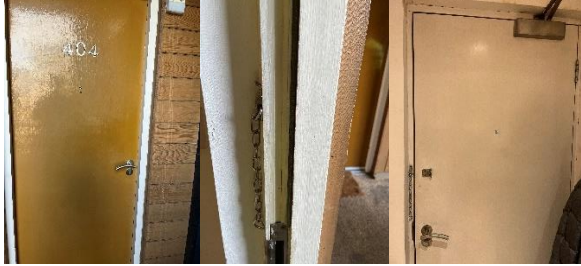
Flat 405

405	FRAME – Make good bottom of jam. HINGES - No Faults. LOCKSET – No Faults. SEALS - No Intumescent pads on hinges and keep. CLOSER – Ease and Adjust. SIGNAGE - N/A. GAPS – Ease and Adjust. DOOR – No Faults. STRUCTURE - No Faults. DOOR FAILED
406	FRAME – No Faults. HINGES - No Faults. LOCKSET – No Faults. SEALS - No Intumescent pads on hinges and keep. Right hand side seal missing. CLOSER – No Faults. SIGNAGE - N/A. GAPS – Ease and Adjust. DOOR – No Faults. STRUCTURE - No Faults. DOOR FAILED
407	FRAME – Joints open and out of line. Damage to Frame. HINGES - No Faults. LOCKSET – Ease and Adjust. Handle loose so needs tightening. SEALS - No Intumescent pads on hinges and keep. CLOSER – Ease and Adjust. SIGNAGE - N/A. GAPS – Ease and Adjust. DOOR – No Faults. STRUCTURE - No Faults. DOOR FAILED
408	FRAME - No Faults. HINGES - No Faults. LOCKSET – No Faults. SEALS - No Intumescent pad on hinges and keep. CLOSER – Need adjusting to prevent future damage. SIGNAGE - N/A. GAPS – Ease and Adjust. DOOR – No Faults. STRUCTURE - No Faults. DOOR FAILED

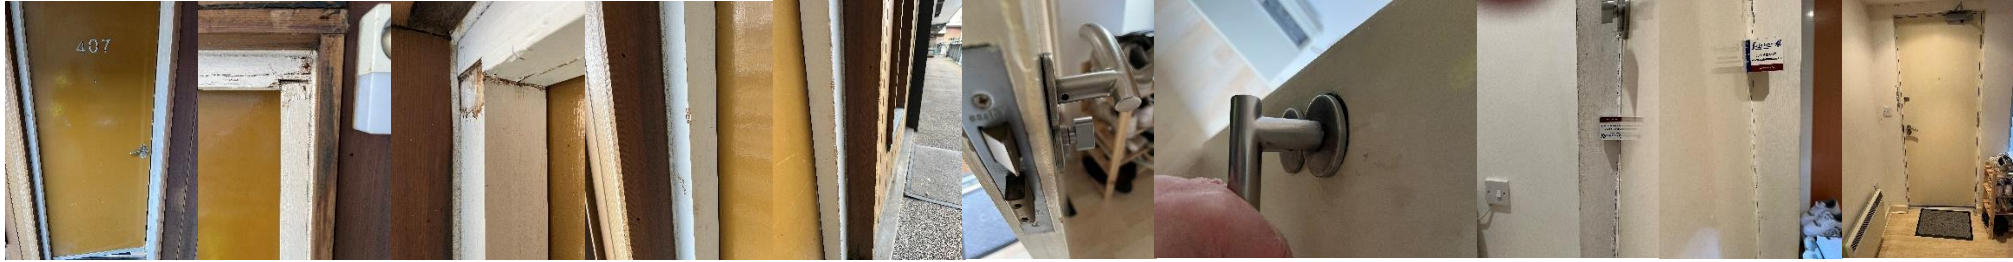
Flat 409

409	FRAME - No Faults. HINGES - No Faults. LOCKSET – No Faults. SEALS - No Intumescent pads on hinges and keep. CLOSER – No Faults. SIGNAGE - N/A. GAPS – Gaps excessive. Door needs replacing. DOOR – New door 830 x 2040 x 44. STRUCTURE - No Faults. DOOR FAILED
410	FRAME – Rot to the bottom of the Jam. Needs to be made good. HINGES - No Faults. LOCKSET – No Faults. SEALS - No Intumescent pads on hinges and keep. CLOSER – Ease and Adjust action. SIGNAGE - N/A. GAPS – New Door. Gaps excessive. DOOR – New Door 828 x 2030 x 44. STRUCTURE - No Faults. DOOR FAILED
411	Not Available
412	FRAME - No Faults. HINGES - No Faults. LOCKSET – No Faults. SEALS - No Intumescent pads on hinges and keep. CLOSER – No Faults. SIGNAGE - N/A. GAPS – Ease and Adjust. DOOR – No Faults. STRUCTURE - No Faults. DOOR FAILED
413	FRAME - No Faults. HINGES - No Faults. LOCKSET – No Faults. SEALS - No Intumescent pads on hinges and keep. CLOSER – No Faults. SIGNAGE - N/A. GAPS – Ease and Adjust. DOOR – No Faults. STRUCTURE - No Faults. DOOR FAILED

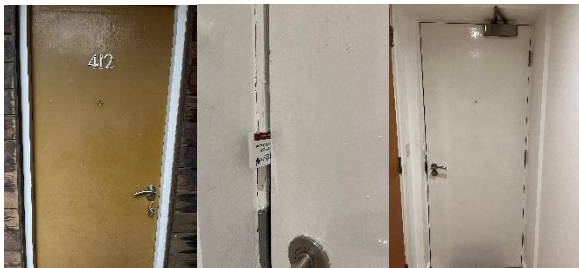
Flat 414

414	FRAME - No Faults. HINGES - No Faults. LOCKSET – No Faults. SEALS - No Intumescent pads on hinges and keep. CLOSER – No Faults. SIGNAGE - N/A. GAPS – Ease and Adjust. DOOR – No Faults. STRUCTURE - No Faults. DOOR FAILED
415	FRAME - No Faults. HINGES - No Faults. LOCKSET – No Faults. SEALS - No Intumescent pads on hinges and keep. CLOSER – No Faults. SIGNAGE - N/A. GAPS – Ease and Adjust. DOOR – No Faults. STRUCTURE - No Faults. DOOR FAILED
416	FRAME - No Faults. HINGES - No Faults. LOCKSET – Loose Handle. SEALS - No Intumescent pads on hinges and keep. CLOSER – No Faults. SIGNAGE - N/A. GAPS – Ease and Adjust. DOOR – No Faults. STRUCTURE - No Faults. DOOR FAILED
Fire Door North Block 4th floor	FRAME – No Faults. HINGES – No Faults. LOCKSET – N/A. SEALS – No Intumescent pads on hinges and keep. Rubber seal is over the intumescent seal. CLOSER – No Faults. SIGNAGE No Faults. GAPS – Ease and Adjust. DOOR – No Faults. STRUCTURE - No Faults. DOOR FAILED

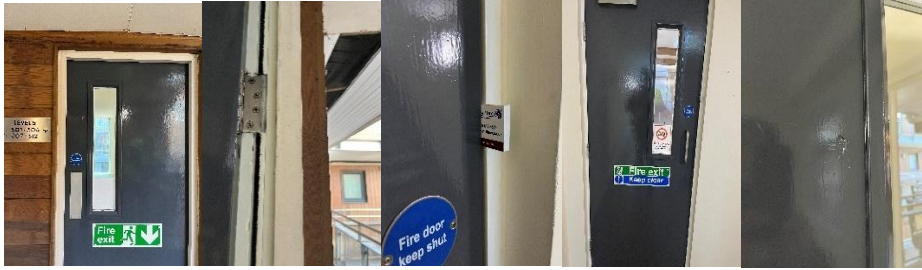
Flat 501

501	FRAME - No Faults. HINGES - No Faults. LOCKSET – Loose and needs adjusting. SEALS - No Intumescent pads on hinges and keep. CLOSER – Cover missing and need replacing. SIGNAGE - N/A. GAPS – Ease and Adjust. DOOR – Damage to the edge of door and can be made good. STRUCTURE - No Faults. DOOR FAILED
502	FRAME - No Faults. HINGES - No Faults. LOCKSET – No Faults. SEALS – Only brush seals. No Intumescent pads on hinges and keep. CLOSER – Needs adjusting. SIGNAGE - N/A. GAPS – No Faults. DOOR – No Faults. STRUCTURE - No Faults. DOOR FAILED
503	FRAME - No Faults. HINGES - No Faults. LOCKSET – Loose and needs adjusting. Screw missing on keep. SEALS - No Intumescent pads on hinges and keep. CLOSER – Needs adjusting. SIGNAGE - N/A. GAPS – Ease and Adjust. DOOR – Damage to edge of door and can be made good. STRUCTURE - No Faults. DOOR FAILED
504	FRAME - No Faults. HINGES - No Faults. LOCKSET – Ease and Adjust. SEALS – No Intumescent pads on hinges and keep. CLOSER – No Faults. SIGNAGE - N/A. GAPS – Ease and Adjust. DOOR – No Faults. STRUCTURE - No Faults. DOOR FAILED

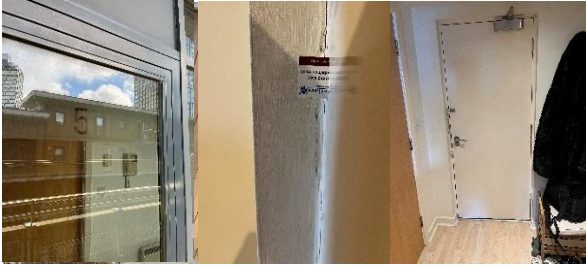
Flat 505

505	FRAME - No Faults. HINGES - No Faults. LOCKSET – No Faults. SEALS – No Intumescent pads on hinges and keep. CLOSER – No Faults. SIGNAGE - N/A. GAPS – Ease and Adjust. DOOR – No Faults. STRUCTURE - No Faults. DOOR FAILED
506	Not Available
507	Not Available
508	Not Available
509	Not Available
510	FRAME – Rotten right hand side Jam and Joint. New frame or repair. HINGES – Screws missing. LOCKSET – No Faults. SEALS – No Intumescent pads on hinges and keep. CLOSER – Cover missing. SIGNAGE - N/A. GAPS – No Faults. DOOR – New door frame 895 x 2080 x 44. STRUCTURE – New frame. DOOR FAILED
511	FRAME - No Faults. HINGES - No Faults. LOCKSET – No Faults. SEALS – Only brush seals. No Intumescent pads on hinges and keep. CLOSER – Needs adjusting. SIGNAGE - N/A. GAPS – No Faults. DOOR – No Faults. STRUCTURE - No Faults. DOOR FAILED
Fire Door South Block Stair Case 5th floor	FRAME – No Faults. HINGES – No Faults. LOCKSET – N/A. SEALS – No Intumescent pads on hinges. No Intumescent seals missing. CLOSER – Ease and Adjust. SIGNAGE No Faults. GAPS – Ease and Adjust. DOOR – Damage to door face and can be made good. STRUCTURE - No Faults. DOOR FAILED

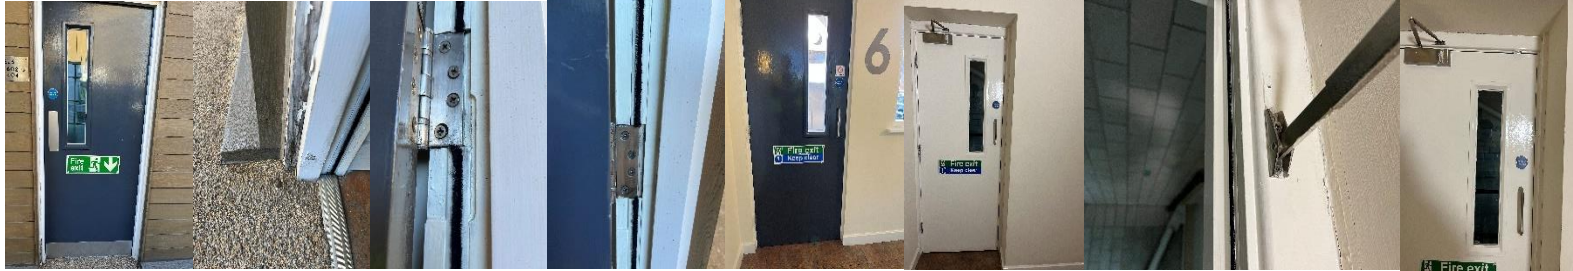
Flat 601

601	FRAME - No Faults. HINGES - No Faults. LOCKSET – No Faults. SEALS – No Intumescent pads on hinges and keep plus 2 mortise locks. CLOSER – No Faults. SIGNAGE - N/A. GAPS – Ease and Adjust. DOOR – No Faults. STRUCTURE - No Faults. DOOR FAILED
602	FRAME – Over cut around the keep and can be repaired. HINGES – Screws are loose. LOCKSET – Loose Handle. Grub screw missing and keep over cut. SEALS – No Intumescent seal on hinge and keep. Intumescent seal is detached. CLOSER – Ease and Adjust. SIGNAGE - N/A. GAPS – Ease and Adjust. DOOR – Damage to the edge of the door. Lipping detached. 830 x 2020 x 44. STRUCTURE - No Faults. DOOR FAILED
603	FRAME - No Faults. HINGES – Different screws. LOCKSET – No Faults. SEALS – No Intumescent pads on hinges and keep. CLOSER – No Faults. SIGNAGE - N/A. GAPS – No Faults. DOOR – No Faults. STRUCTURE - No Faults. DOOR FAILED
604	FRAME – Needs decoration. HINGES - No Faults. LOCKSET – No thumb turn on the inside of door. SEALS – No Intumescent pads on hinges and keep. CLOSER – No Faults. SIGNAGE - N/A. GAPS – Gaps excessive. DOOR – New Door 8030 x 3035 x 44. STRUCTURE - No Faults. DOOR FAILED
