**The Linx Building**

Fire Risk Appraisal External Walls and Attachments

FE02072

Revision J

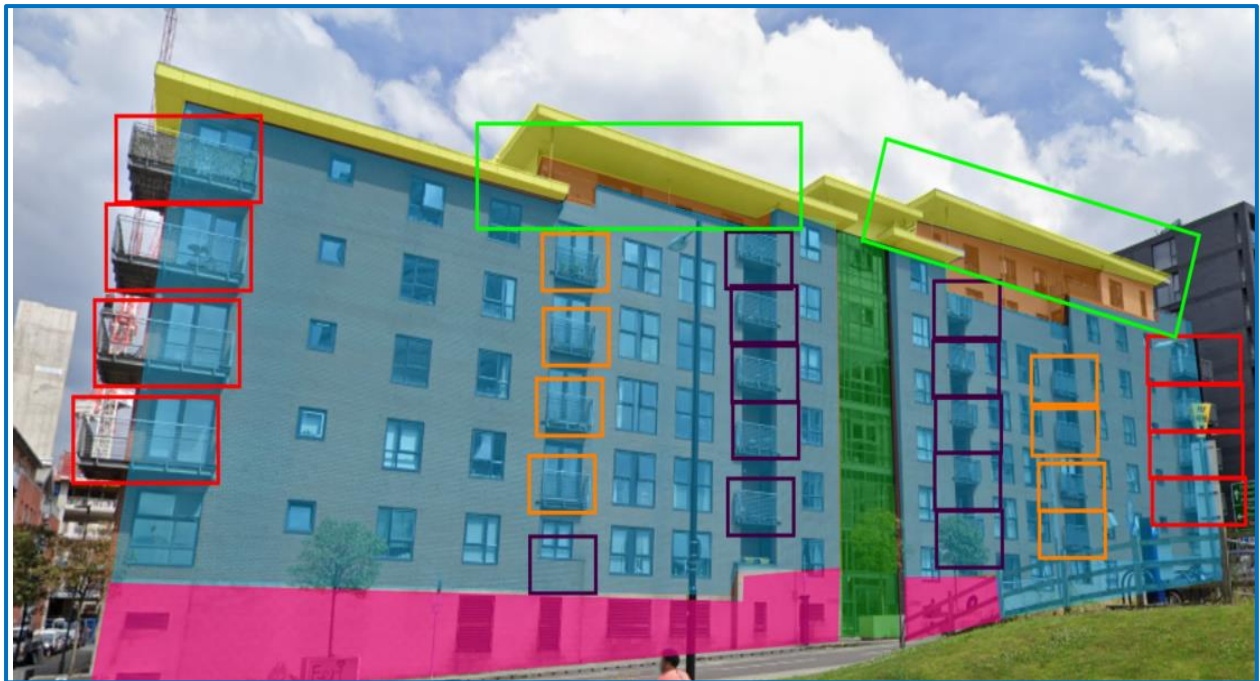
Figure 5 Angel Street elevation extent of cladding (identical to Ludgate Street elevation)

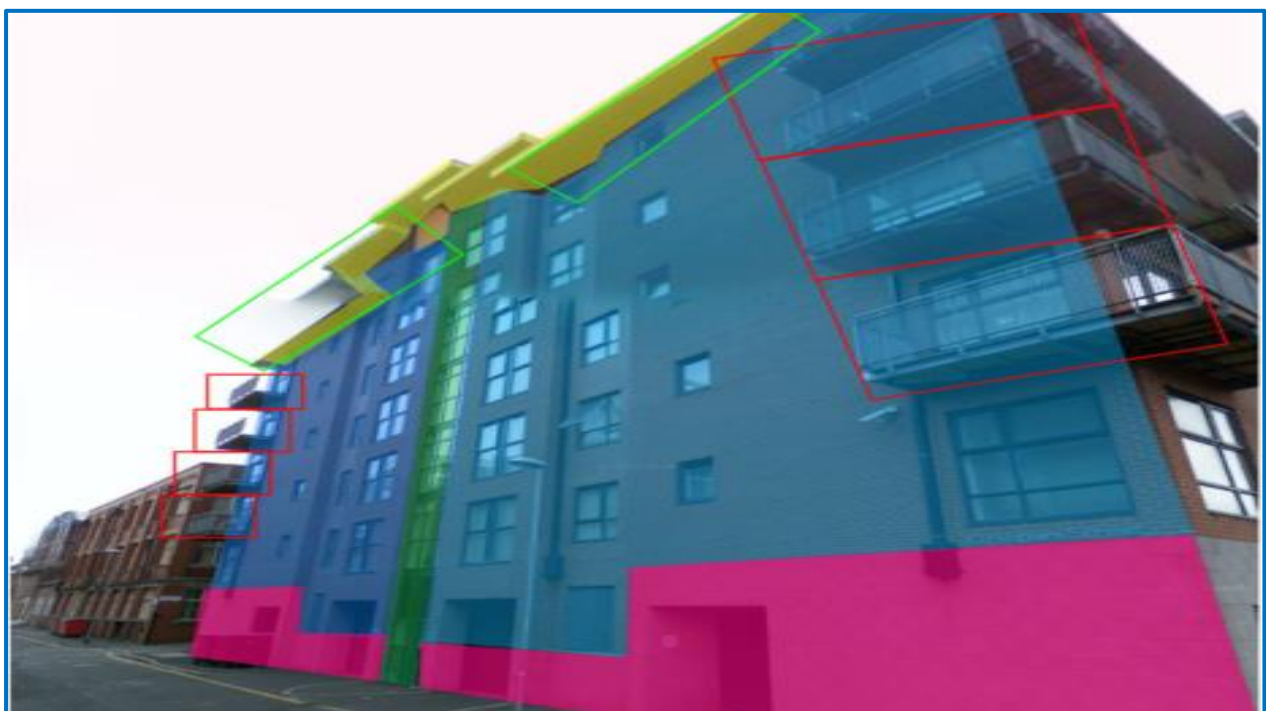
Figure 6 Naples Street elevation extent of cladding

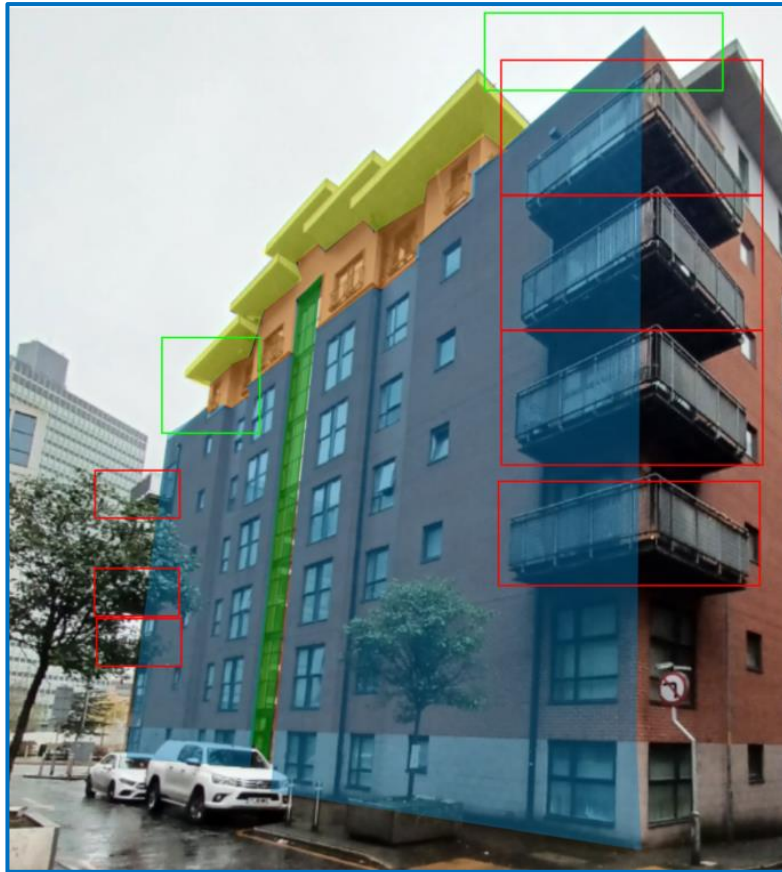
Figure 7 Simpson Street elevation extent of cladding

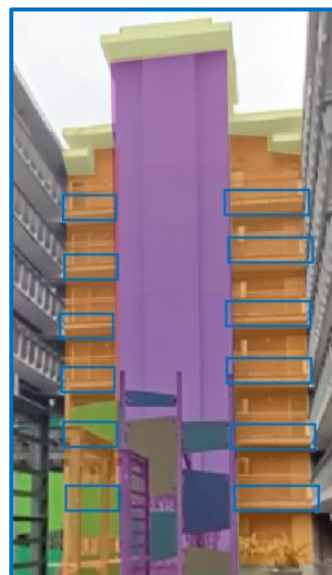
Figure 8 Simpson street courtyard elevation extent of cladding (identical to Napels street courtyard elevation)

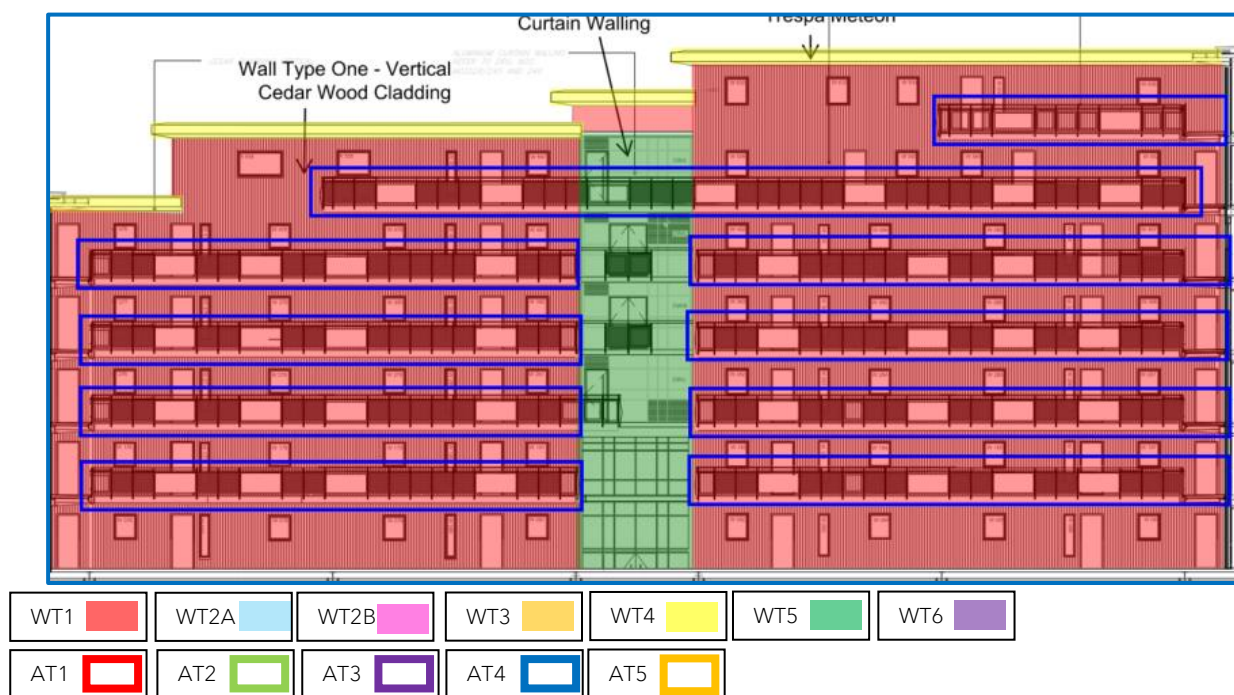
Figure 9 Angel Street courtyard elevation extent of cladding (identical to Ludgate street courtyard elevation)

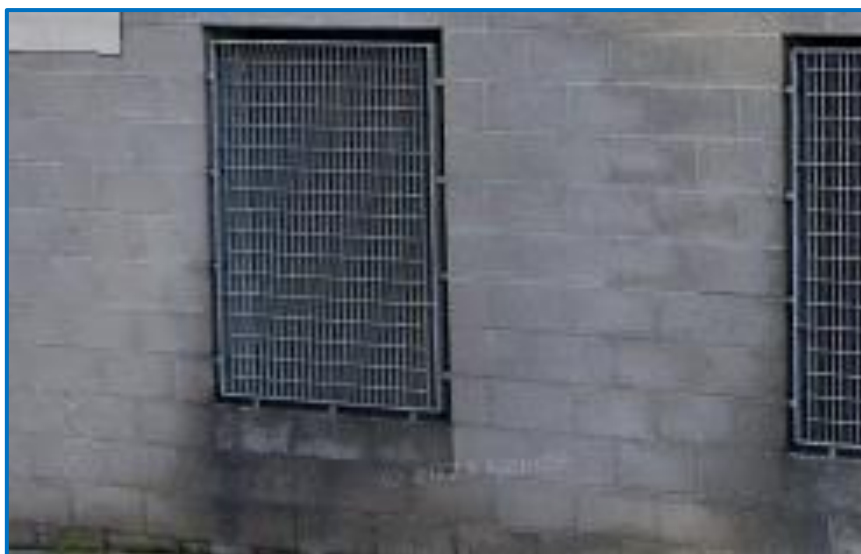
Figure 11: Wall Type 2B – Solid Blockwork

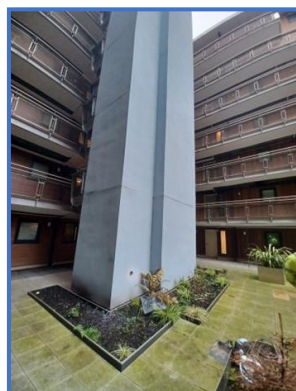
Figure 12: Wall Type 6 – Insulated Render

Recommended Remediation: Where this wall type is used as a decorative soffit, remove and replace all combustible materials in the wall type with materials that achieve Euroclass A2-s1, d0 or better. All combustible membranes must also be removed and replaced with membranes achieving a minimum of class B-s3, d0. Install cavity barriers at the relevant locations in conjunction with the current Building Regulations in Approved Document B.

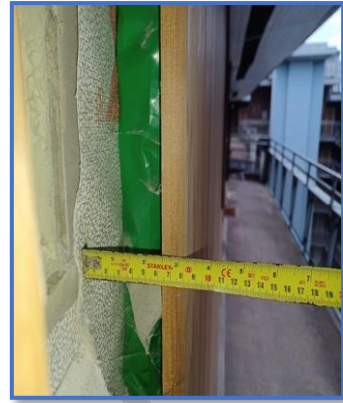
B5

| Wall Build Up: | Description | Photo Reference | Combustibility Rating (Euroclass BS EN 13501) | Classification rating |
|---|---|---|---|---|
| Cavity Barrier:<br>At party wall | A green cavity stop sock was observed between the sheathing board and the timber cladding.<br><br>The cavity between the Fermacell plasterboard and the sheathing board was not closed. | B5, E5 & G5 | N/A | |

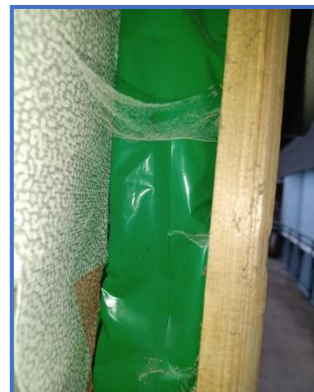
| Wall Build Up: | Description | Photo Reference | Combustibility Rating (Euroclass BS EN 13501) | Classification rating |
|---|---|---|---|---|
| Cavity Barrier:<br>At party wall | A red cavity stop sock was observed between the sheathing board and the timber cladding. | B6 & G5 | N/A | |

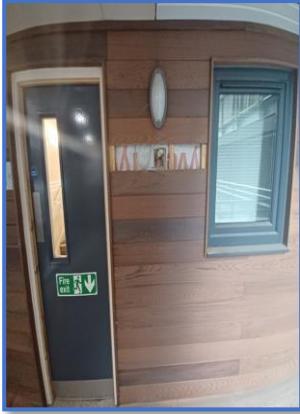
| Wall Build Up: | Description | Photo Reference | Combustibility Rating (Euroclass BS EN 13501) | Classification rating |
|---|---|---|---|---|
| Cavity Barrier:<br>At compartment wall | A cavity barrier was not observed between the sheathing board and the timber cladding. | A9 | N/A | |

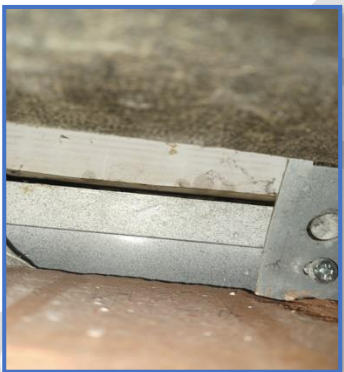
**E10**

| Wall Build Up: | Description | Photo Reference | Combustibility Rating (Euroclass BS EN 13501) | Classification rating |
|---|---|---|---|---|
| Cavity Barrier:<br>At window cill | Not present.<br><br>Only the window frame was observed. | E10 | N/A | |

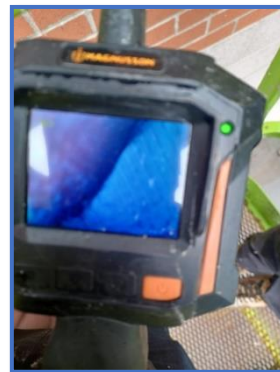
**F10**

| Wall Build Up: | Description | Photo Reference | Combustibility Rating (Euroclass BS EN 13501) | Classification rating |
|---|---|---|---|---|
| Cavity Barrier:<br>At window jamb | Not present.<br><br>Only the window frame was observed. | F10 | N/A | |

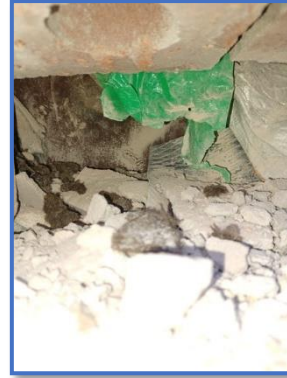
**B12**

| Wall Build Up: | Description | Photo Reference | Combustibility Rating (Euroclass BS EN 13501) | Classification rating |
|---|---|---|---|---|
| Cavity Barrier:<br>At party wall | Present in the form of a green stop sock between the brick and the sheathing board.<br><br>It should be noted that the vertical did not extend the full vertical length of the building, as it stopped at the floor slab level, which was not provided with a horizontal cavity barrier. | B12 & C12 | N/A | |

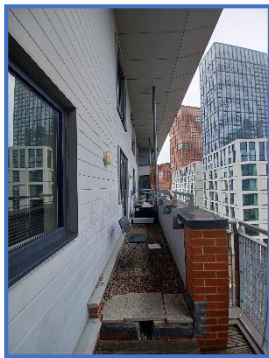
**A15**

This location was not inspected due to safety concerns. The small size of the balcony made it unsafe to mount a ladder for access. As a result, a physical inspection could not be conducted. For further context, please refer to photo reference A15, which clearly shows the limited dimensions of the balcony, highlighting the challenges and risks associated with attempting to carry out an inspection in such a limited space. The cherry picker could also not access the location.

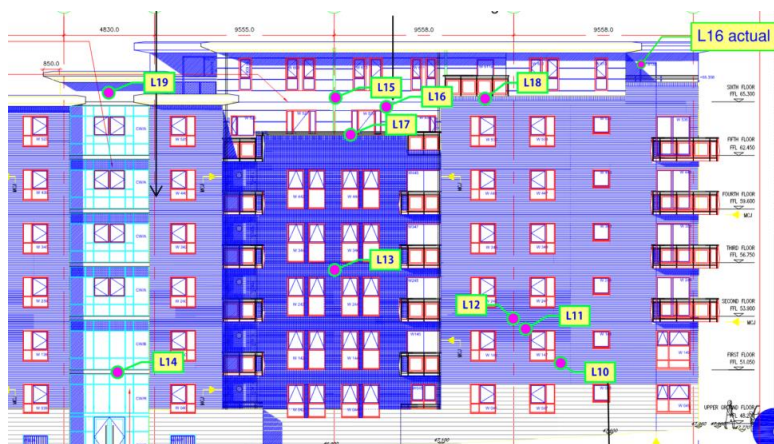
Figure 15 L16 location change

This location was changed due to access issues as per Figure 15 . Only the location was adjusted; the intent remains the same.

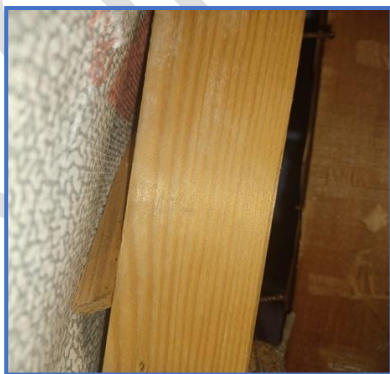
**C16**

| Wall Build Up: | Description | Photo Reference | Combustibility Rating (Euroclass BS EN 13501) | Classification rating |
|---|---|---|---|---|
| Cavity Barrier:<br>At door head | A 20mm timber batten at the head of the door is observed. | C16 | N/A | |

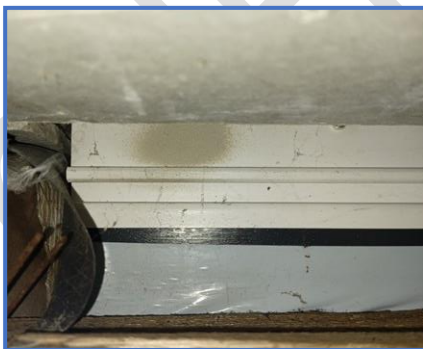
**E17**

| Wall Build Up: | Description | Photo Reference | Combustibility Rating (Euroclass BS EN 13501) | Classification rating |
|---|---|---|---|---|
| Cavity Barrier:<br>At window head | Cavity barrier not observed.<br><br>Window cill closes the cavity. | E17 | N/A | |

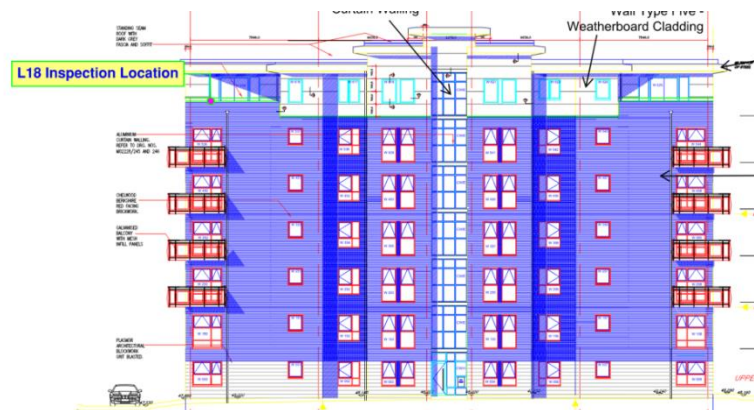
Figure 16 L18 location change

This location was changed due to access issues as per Figure 16. Only the location was adjusted; the intent remains the same.

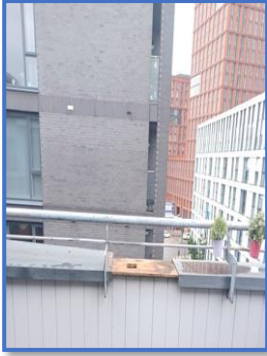
**A18**

| Wall Build Up: | Description | Photo Reference | Combustibility Rating (Euroclass BS EN 13501) | Classification rating |
|---|---|---|---|---|
| Cavity Barrier:<br>Cavity closer | The cavity was closed by a metal coping and a 20mm timber board. Within the void, a further metal element was observed closing the parapet void. | A18, B18 and D18 | N/A | |

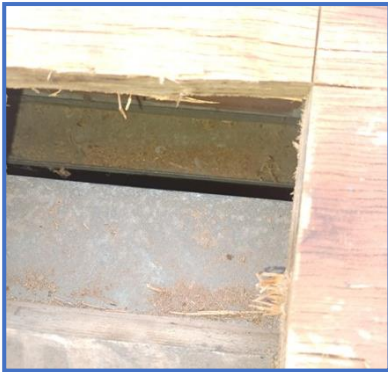
**C18**

| Wall Build Up: | Description | Photo Reference | Combustibility Rating (Euroclass BS EN 13501) | Classification rating |
|---|---|---|---|---|
| Top of Parapet wall | At the top of the parapet wall, several steel elements were observed, which are likely structural. The external surface is brickwork, while the internal balcony surface features timber cladding | C18 | N/A | |

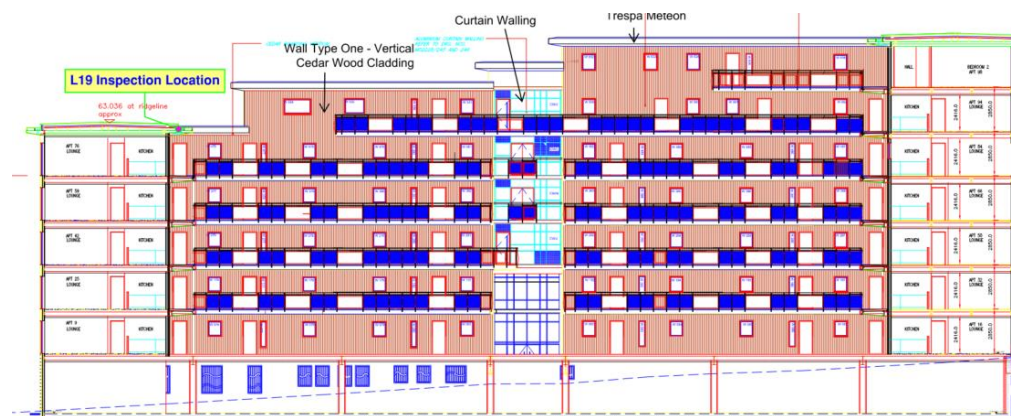
Figure 17 L19 location change

This location was changed due to access issues as per Figure 17. Only the location was adjusted; the intent remains the same.

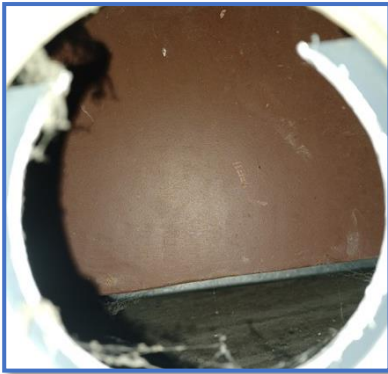
**C19**

| Wall Build Up: | Description | Photo Reference | Combustibility Rating (Euroclass BS EN 13501) | Classification rating |
|---|---|---|---|---|
| Structural element | The Trespa cladding appears to be decorative, primarily used to cover the steel structural element behind it. No other components were observed behind the cladding at this location. | C19 | N/A | |

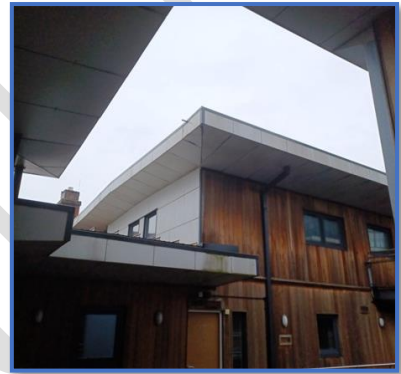
**D19**

The extent of this wall type was confined to the uppermost part of the building, typically spanning the roof soffit overhang. Its primary function appears to be decorative however, there is one specific location where this wall type is used more functionally as a standard wall. This occurs on the Naples Street elevation, specifically on the fifth floor. This particular application of the wall type can be observed in photo reference D19.

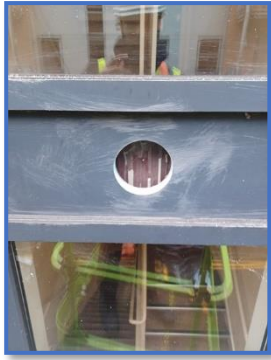
| Wall Build Up: | Description | Photo Reference | Combustibility Rating (Euroclass BS EN 13501) | Classification rating |
|---|---|---|---|---|
| Firestop:<br>At floor slab level | Not present.<br><br>It should be noted that this location was on a stair core, hence fire stops are not required in this location. | A20 & B20 | N/A | |

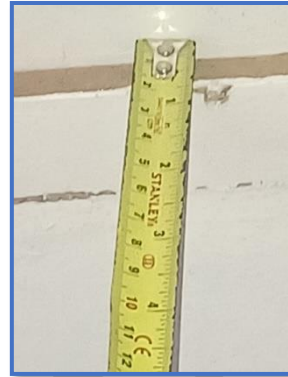
**B22**

| Wall Build Up: | Description | Photo Reference | Combustibility Rating (Euroclass BS EN 13501) | Classification rating |
|---|---|---|---|---|
| Soffit 2 | Two types of soffit materials were observed; one of them was a 20mm plywood board.<br><br>This was fixed to the steel balcony structure via timber framing. | B22 | D | |
